120 INCH TELESCOPE COUDE' SUPPORT FRAME ADJUSTMENT

INSTALLATION OF SOUTH SUPPORT - COUDE' ROOM

COUDE' FRAME ALIGNMENT

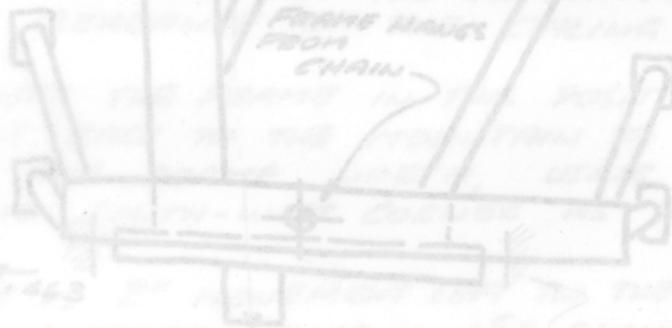
PUSH-SCREWS
THAT MEANS IF WE MOVE THE FRAME THE REQUIRED
AMOUNT NORTH - WE WOULD HAVE TO MOVE THE
PERISCOPE, CHISEL OUT THE WALL FOR THE NO VII
GRATING. REALIGN THE METAL TUBE FOR THE
COMPARISON LIGHTS AND TAKE A GOOD LOOK AT
THE CHAIN FROM WHICH THE FRAME HANGS.

DR. HERBIG SUGGESTED TO TAKE A LOOK AT THE COLLI-
MATORS AND SEE IF THEY COULD BE MOVED.
I FOUND THAT THE $6\frac{1}{2}$ " COLLIMATOR COULD BE MOVED
EAST BY 0.75" AND THE $9\frac{1}{2}$ " COLLIMATOR CAN BE
MOVED BY MORE THAN 2".

$6\frac{1}{2}$ " COLLIMATOR
I WOULD SUGGEST TO MOVE THE FRAME ENOUGH TO
GET THE SLIT ON THE ROTATIONAL AXIS OF THE TELE-
SCOPE (IT SHOULD BE REALLY CLOSE AT PRESENT
ACCORDING TO GENE HARLIANS MEASUREMENTS)
AND THEN MOVE THE COLLIMATORS TO CENTER
OF THE POLAR AXIS.

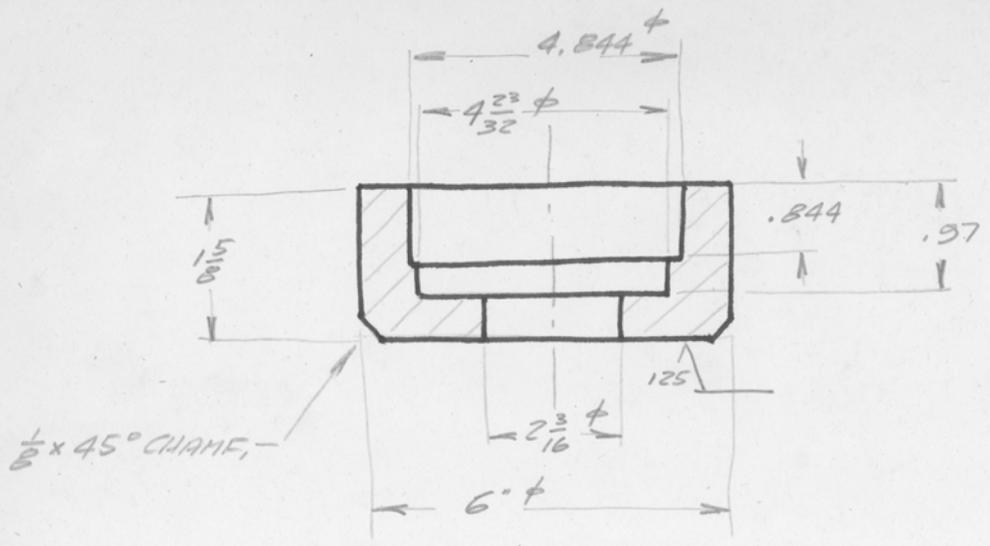
COUDE' WEST SUPP'T
BEARING BASE

1 - REQ'D
MAT'L. : TOOL STEEL HI CARB. HI CR.
FINISH : AIR HARDEN 58-60 ROCKW.
