# 120 INCH TELESCOPE PRIMARY RECOATING

February 13 – 16, 2006

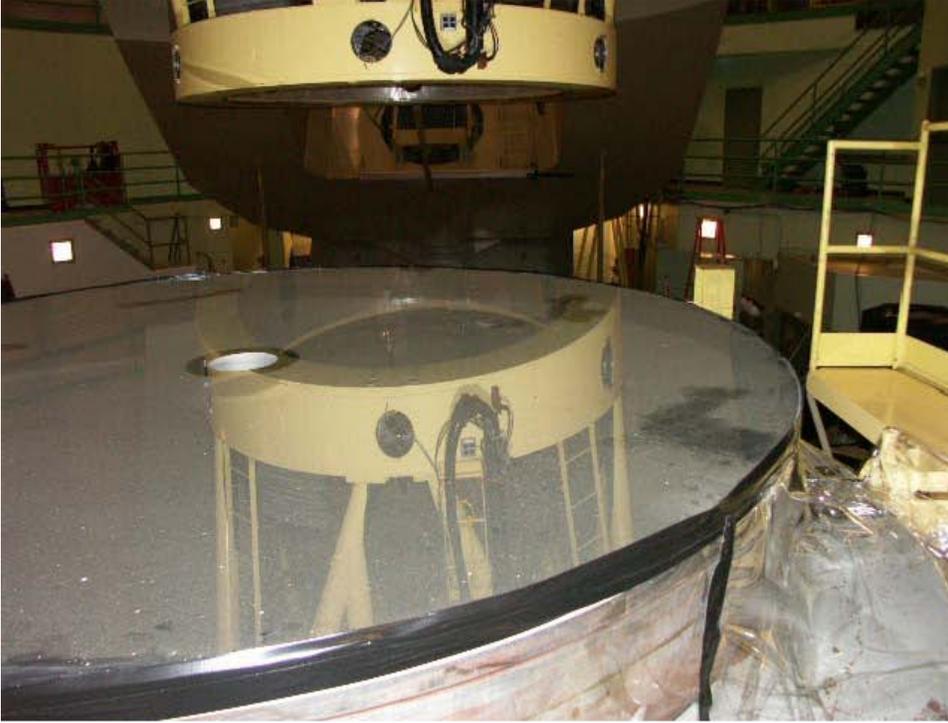
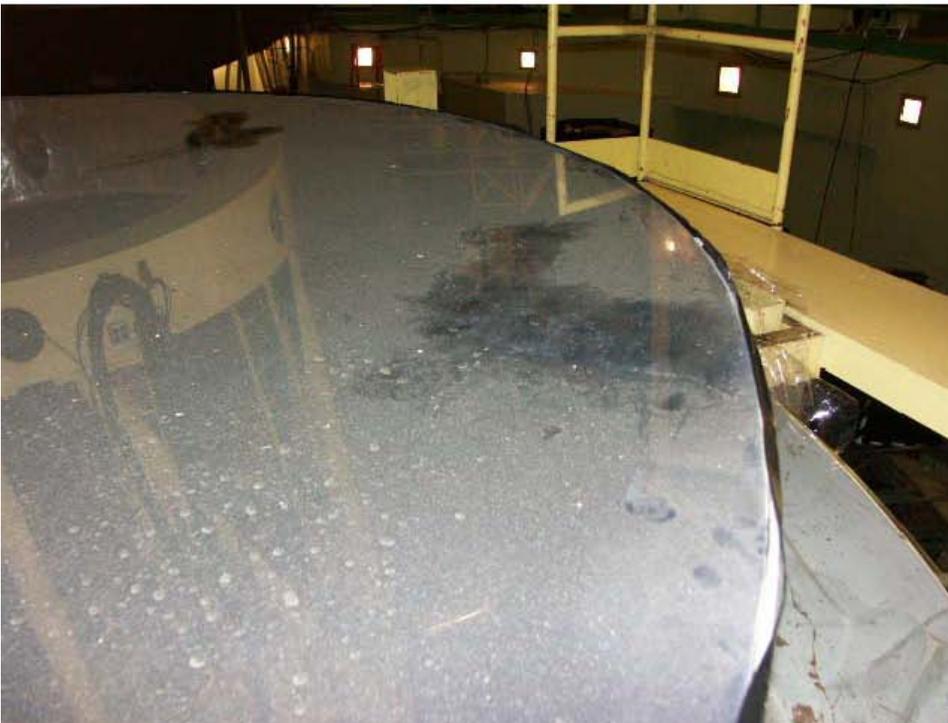
On top of the vinyl we made a ½" dam around the circumference by folding a piece of 2" duct tape over on itself and sticking the unfolded portion down on the vinyl. The result was designed to keep the fluids on the mirror, flowing into the central hole, and not off the edges and onto surfaces and people below. The central hole was connected to a drain line that was held in place by an inflatable tube (not shown)...it drained to the darkroom sink. For future re-coats we recommend a pre-formed dam, possibly of plastic.

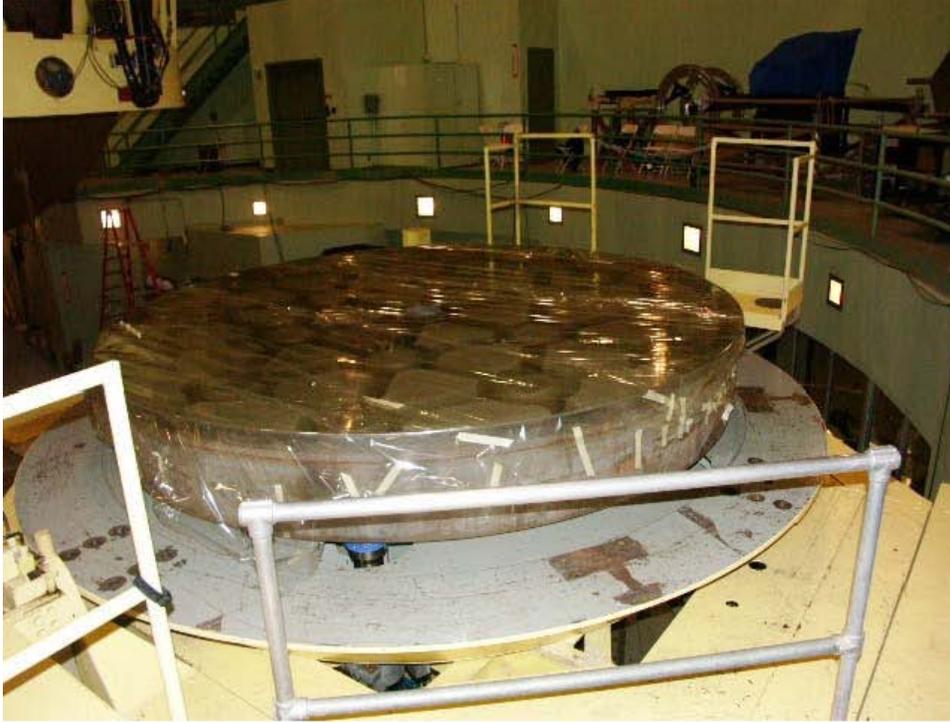
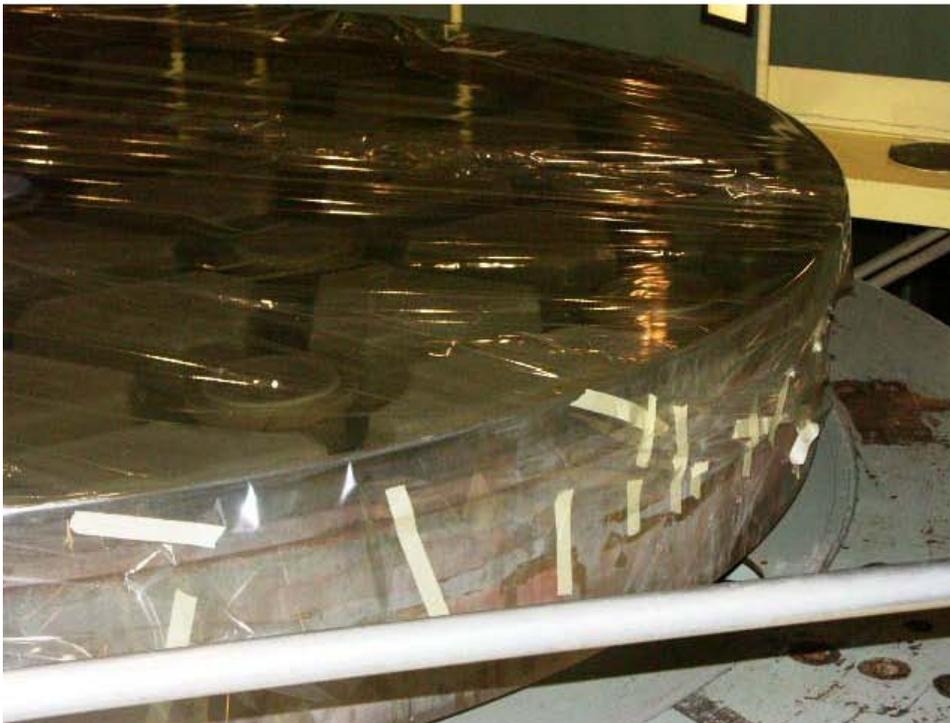
The last step for the night was to cover the mirror with cellophane, which came on a roll in a 4' wooden box. We taped it to the edge of the mirror on one side and unrolled it without dragging it on the surface, then taped it down on the other side. This is another area where we suggest improvement...perhaps a giant shower cap made of sail-cloth or some other light material. Something in the center hole would keep it from touching the surface of the mirror.

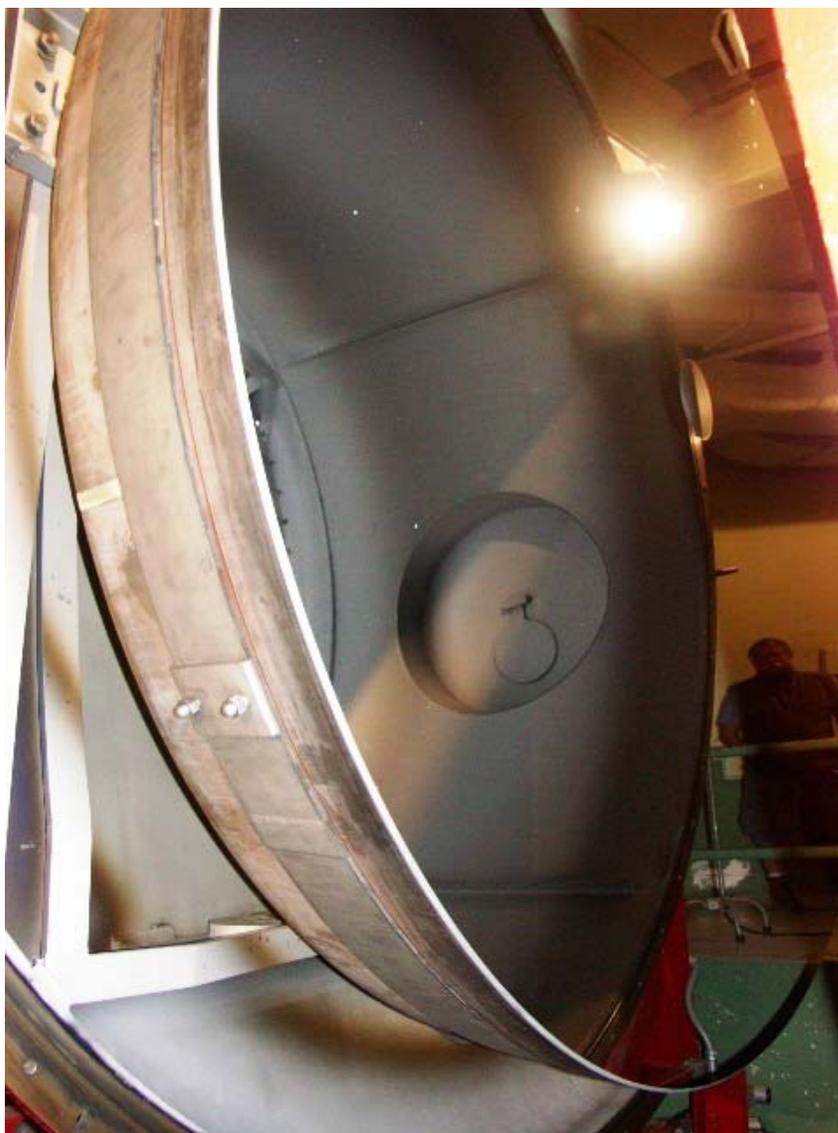
After the coating process we vented the tank and opened it to see if we would need to strip it the next day. It seemed good, although there were some smudges that looked like cleaning residue in the southeast quadrant (which would have been up and to the left looking at the mirror hanging vertically).

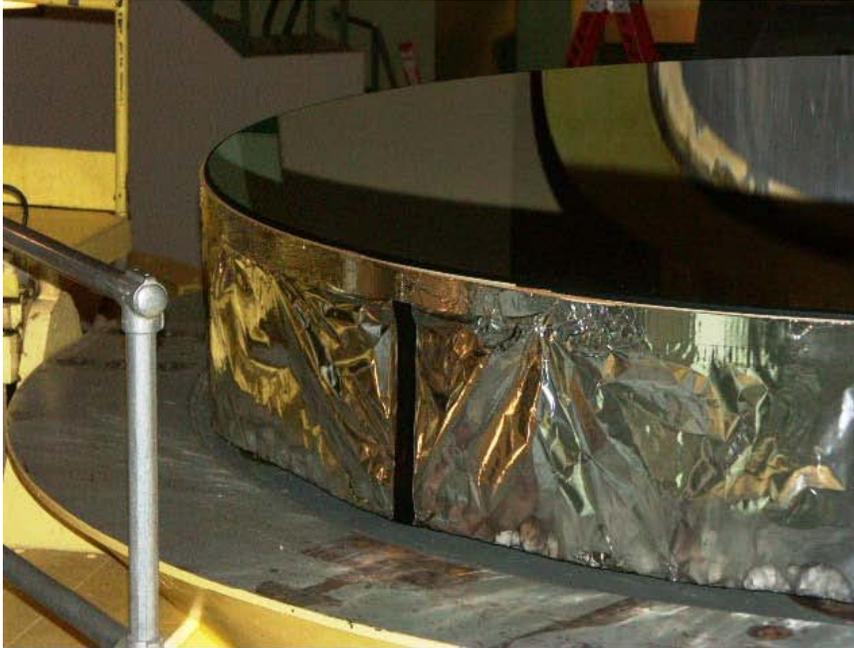
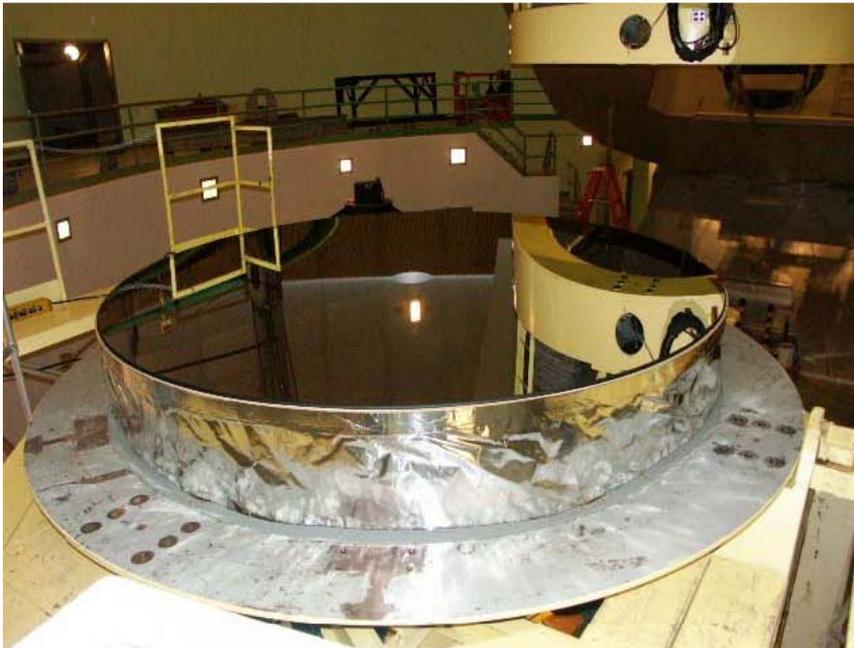
Once there, we put a new skirt of foil around it. We changed the procedure slightly in that we used black duct tape in place of the beige masking tape in direct contact with the mirror. This was because it had been hard to get the old tape off and it was thought that the fiber backing of the duct tape would make it come off easier (we anticipate having to remove more tape residue with acetone).

We noticed when we put corrugated cardboard around it that the cardboard shed lots of fibers onto the surface of the pristine mirror. It was never blown off, to my knowledge. We recommend finding an equivalent material that is lint-free, like a foam strip, perhaps.

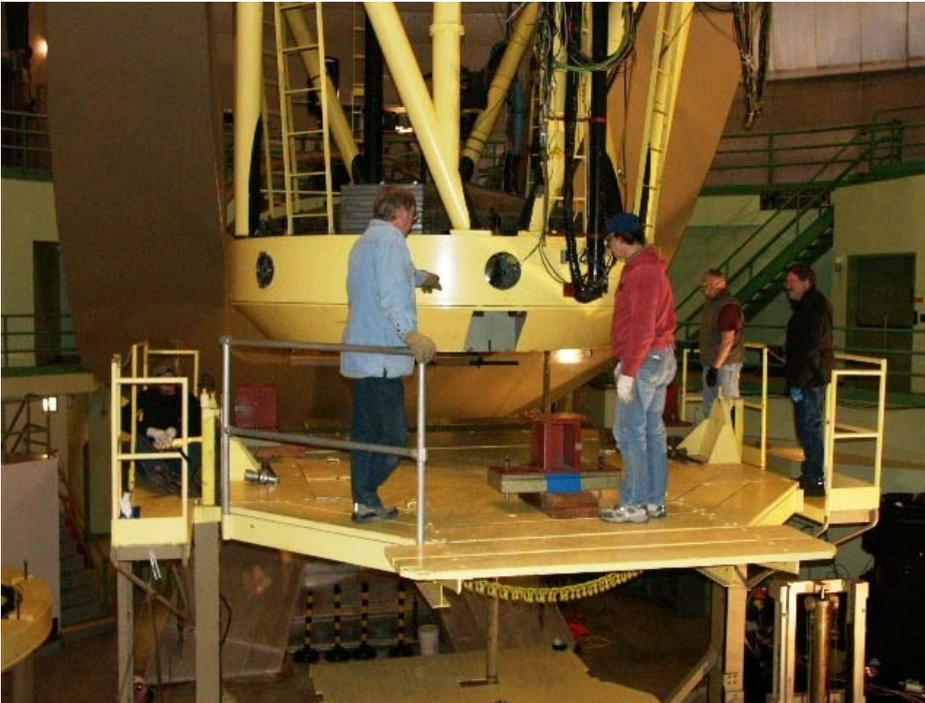
Later the other three were put on the platform. It was noted that the alignment marks for the weights had been painted over, so there was some pushing and pulling on the massive weights that was required to get them in to position. Next time the mirror comes out the positions of the weights should be re-marked before they are taken off. This will make replacing them much easier.

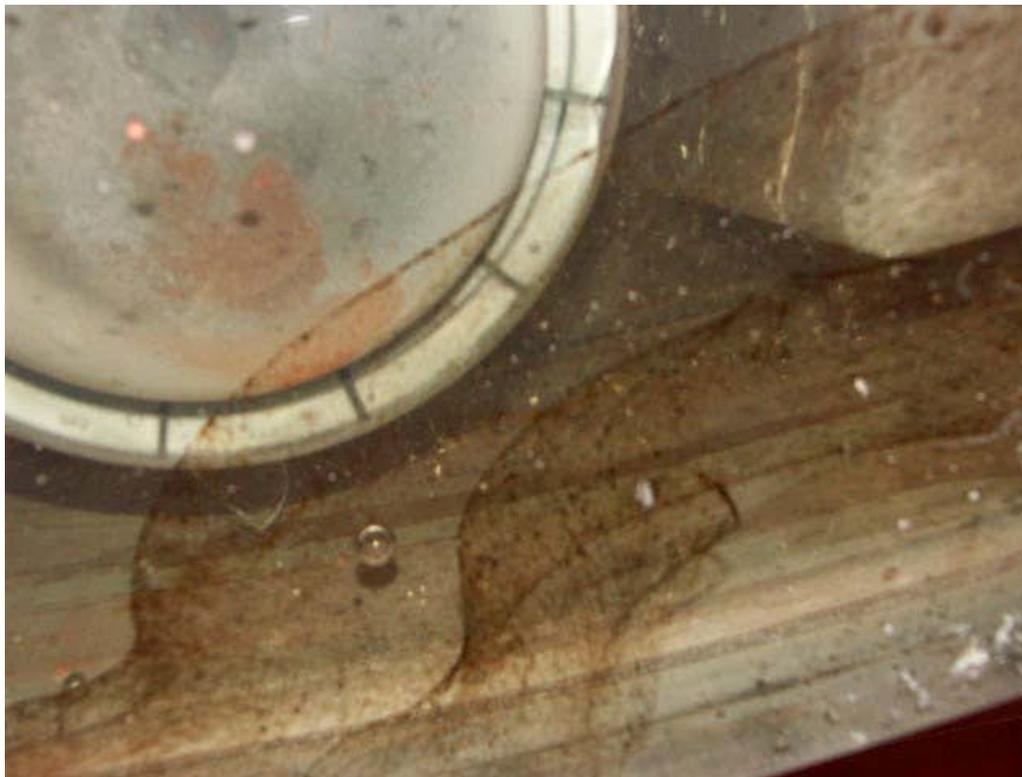
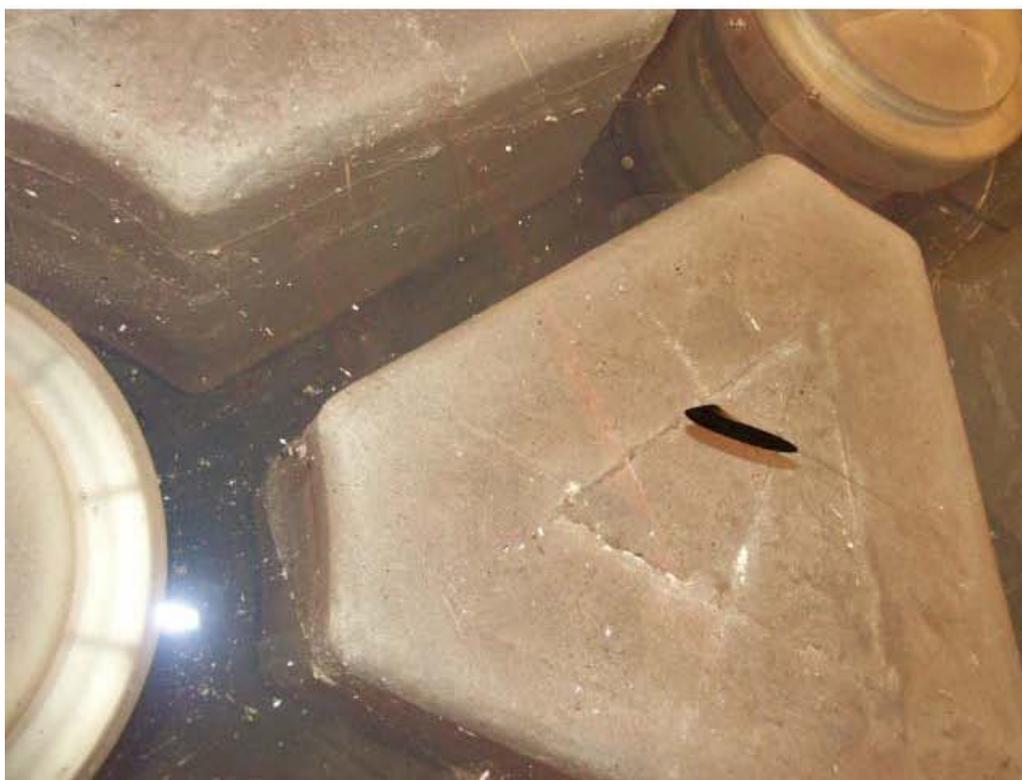
## Addendum 1 - Photos of the substrate of the mirror.

There were lots of floating debris and swirls of brown fluid beneath the surface.

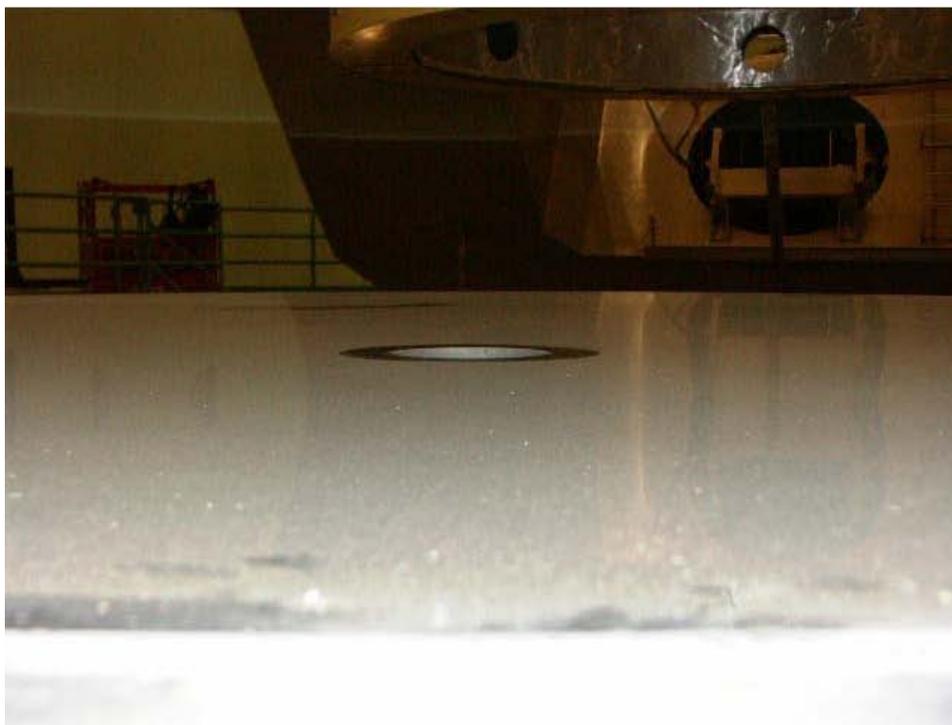
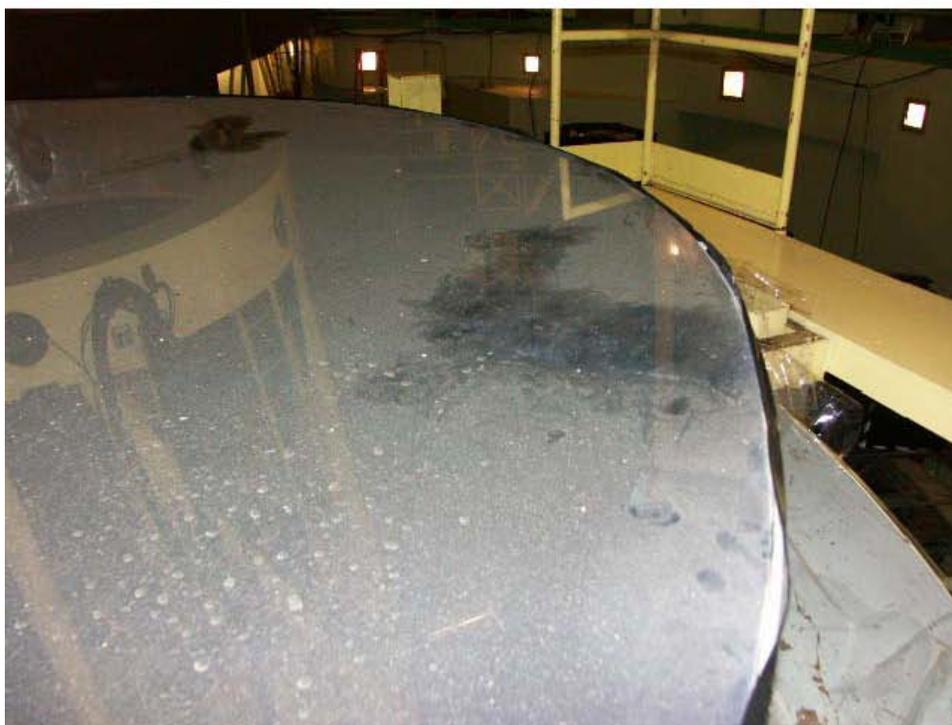
## Addendum 2 – Original surface of mirror

The ring near the center was blocked by the “top hat” that goes in the center hole.
