120 INCH TELESCOPE COUDE' SUPPORT FRAME ADJUSTMENT

INSTALLATION OF SOUTH SUPPORT - COUDE' ROOM

COUDE' FRAME ALIGNMENT

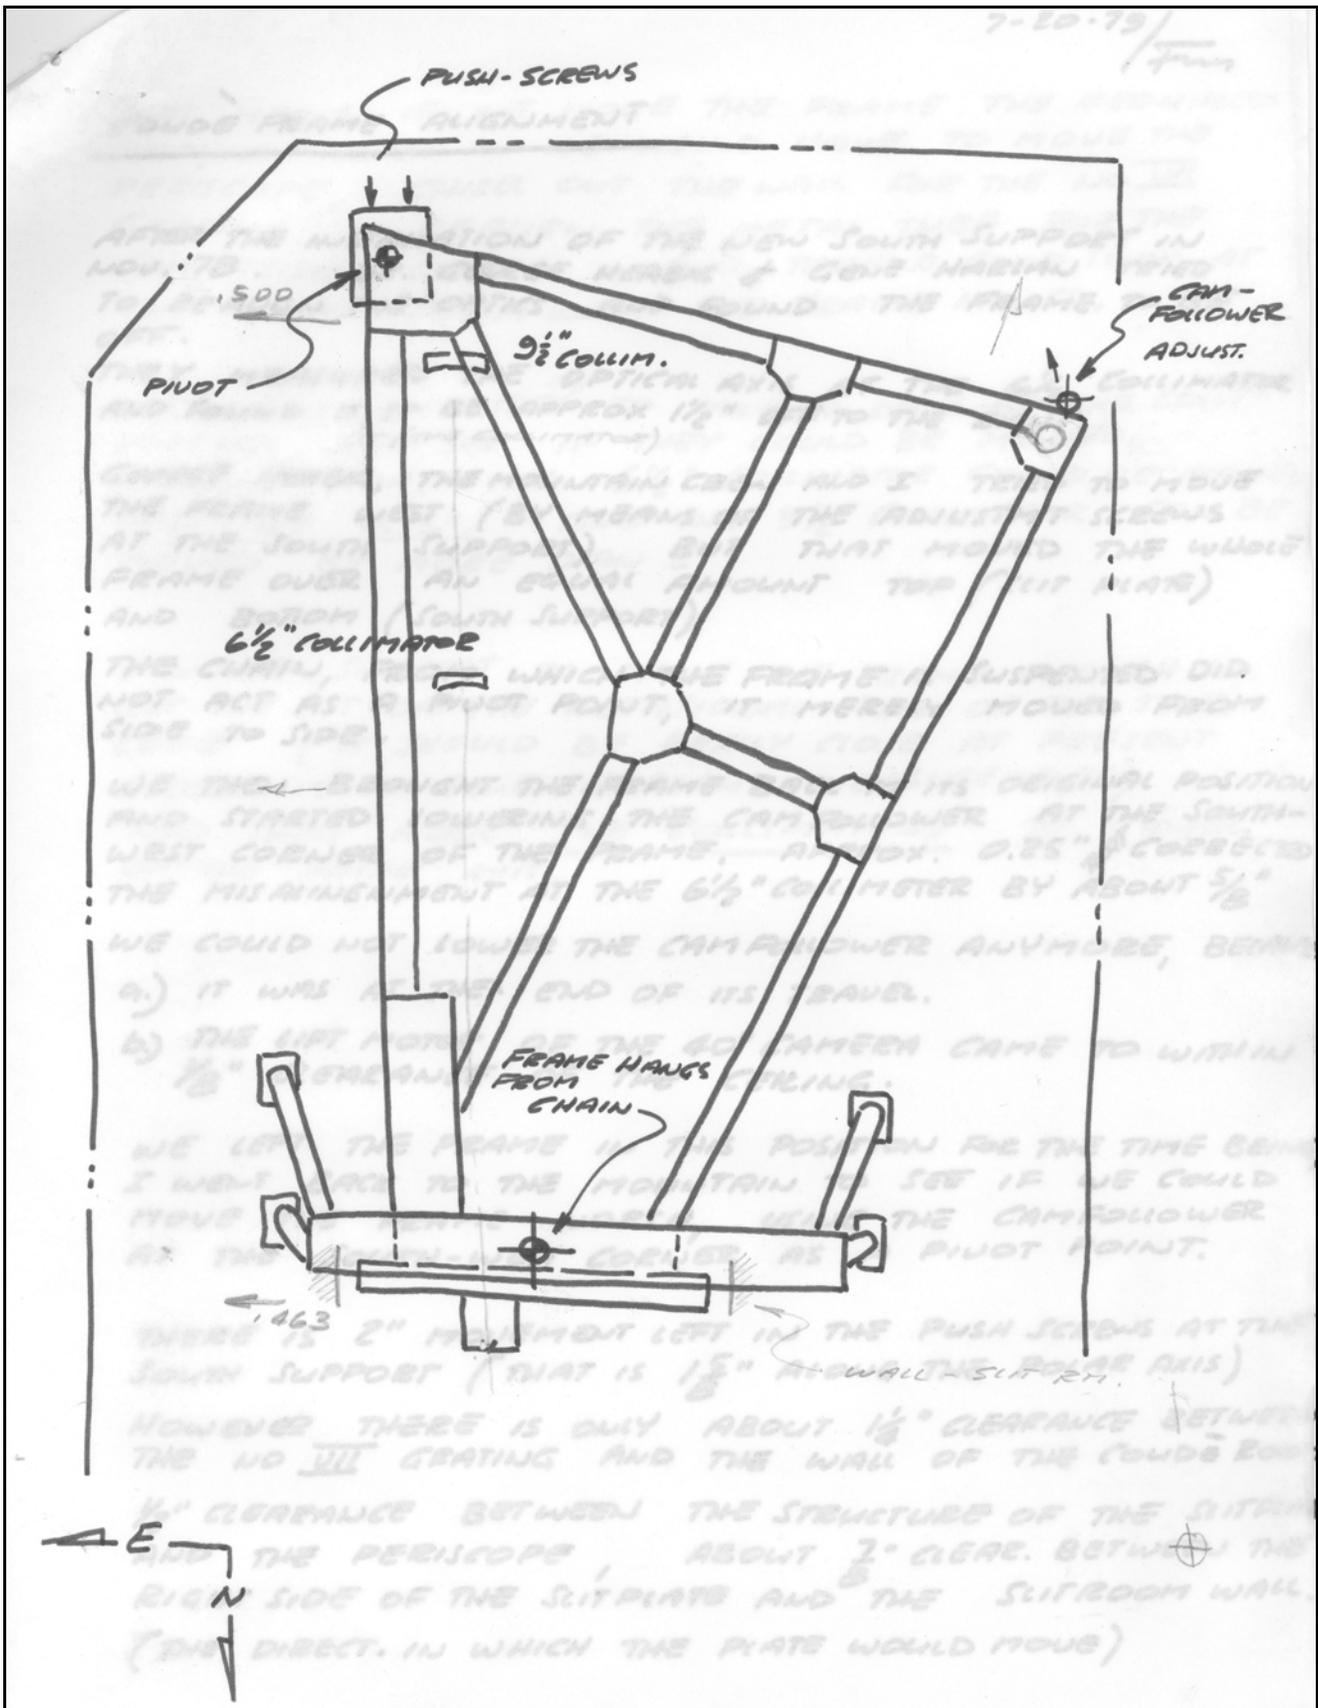
120 INCH TELESCOPE COUDE' SUPPORT FRAME ADJUSTMENT

WE PLACED JACKS AND COMEALONGS AT VARIOUS PLACES (SEE SHEET II & III) UNDER THE FRAME AND RAISED THE SOUTH CORNER APPROX. $3\frac{1}{2}$ " TO CLEAR THE STUDS THAT ARE IMBETTED IN THE PIER.
