# 120 INCH TELESCOPE PRIMARY RECOATING

February 13 – 16, 2006

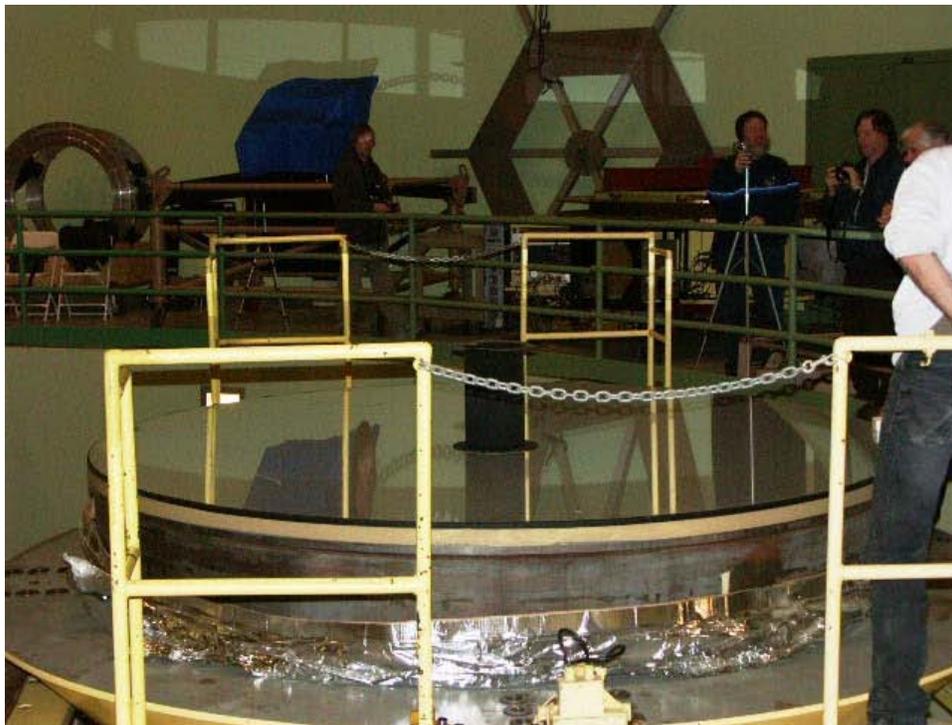
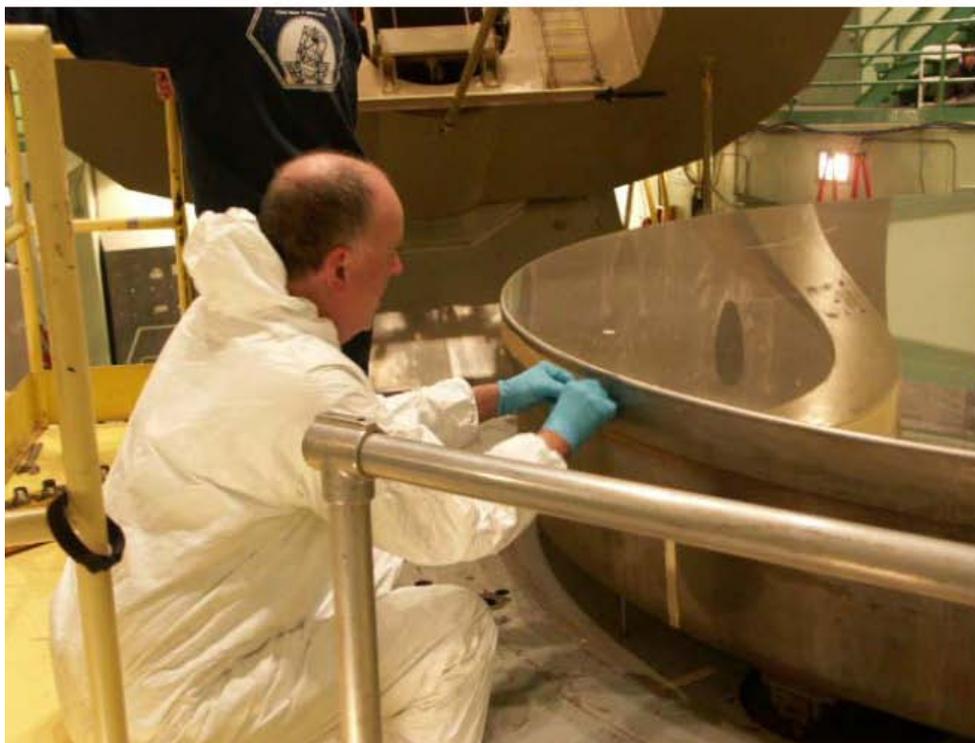
We next removed the old foil, tape and cardboard from around the circumference of the mirror, cleaning off the tape residue with acetone.

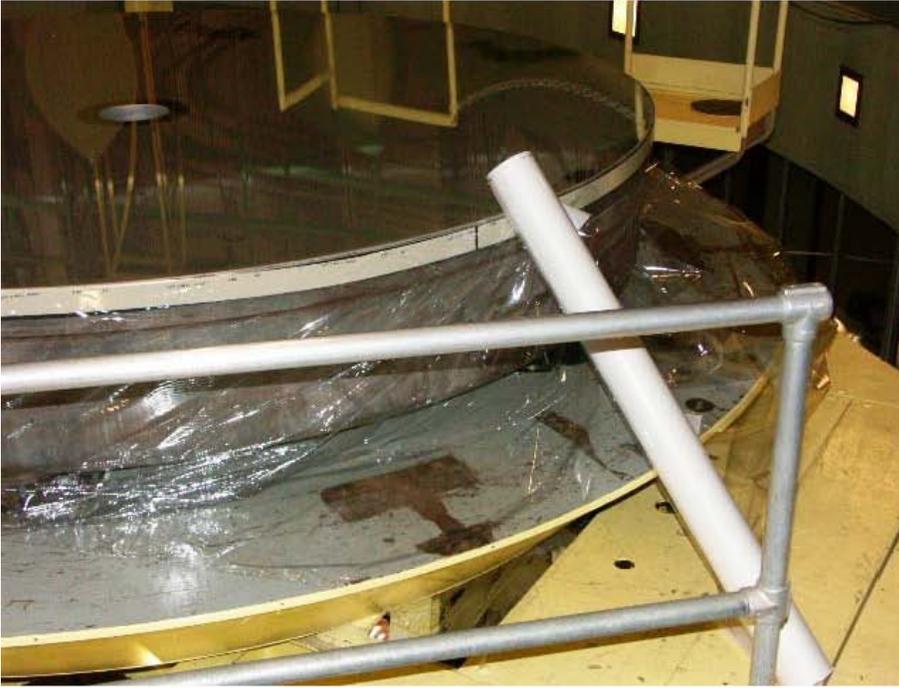
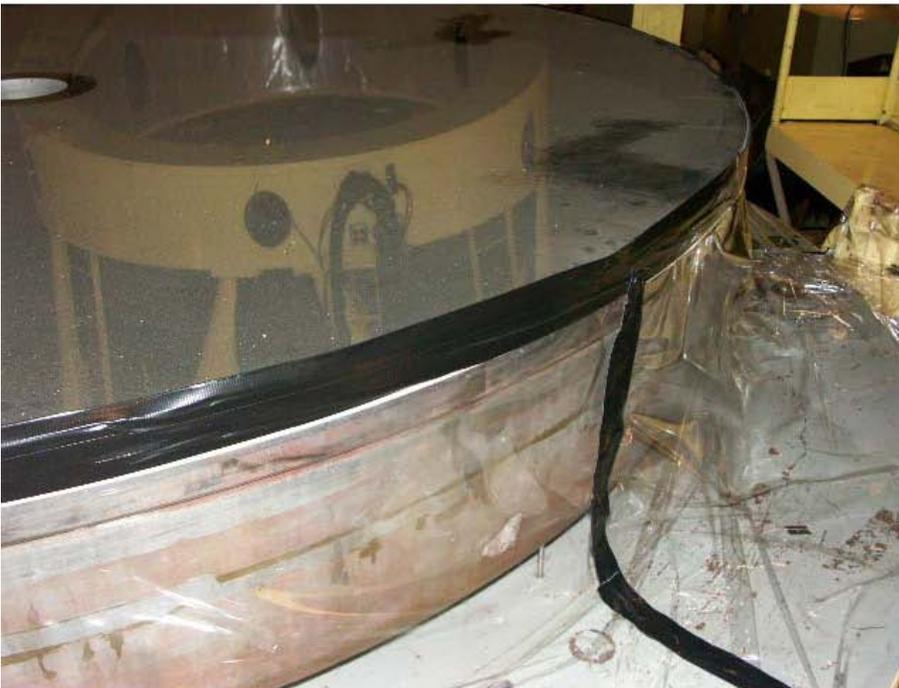
We then used a layer of masking tape and a layer of double-sided tape to attach a 3' or 4' wide skirt of vinyl to the mirror, draping it down to protect the painted surfaces and the people working below from the fluids we were preparing to use. We had to put the vinyl on in several sections, and we were careful to overlap the sections with more vinyl and to seal the joints with duct tape.

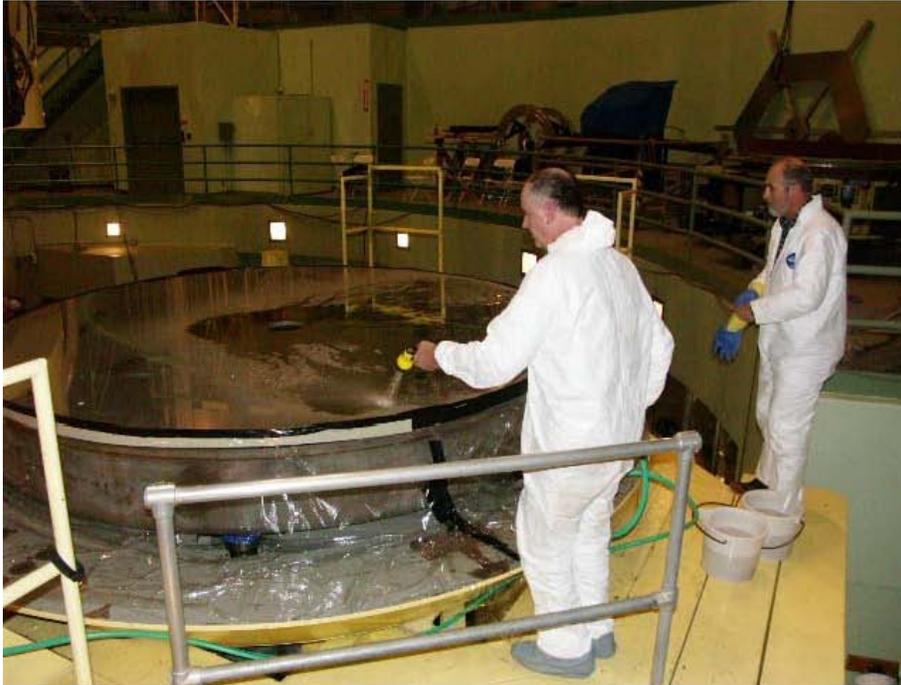
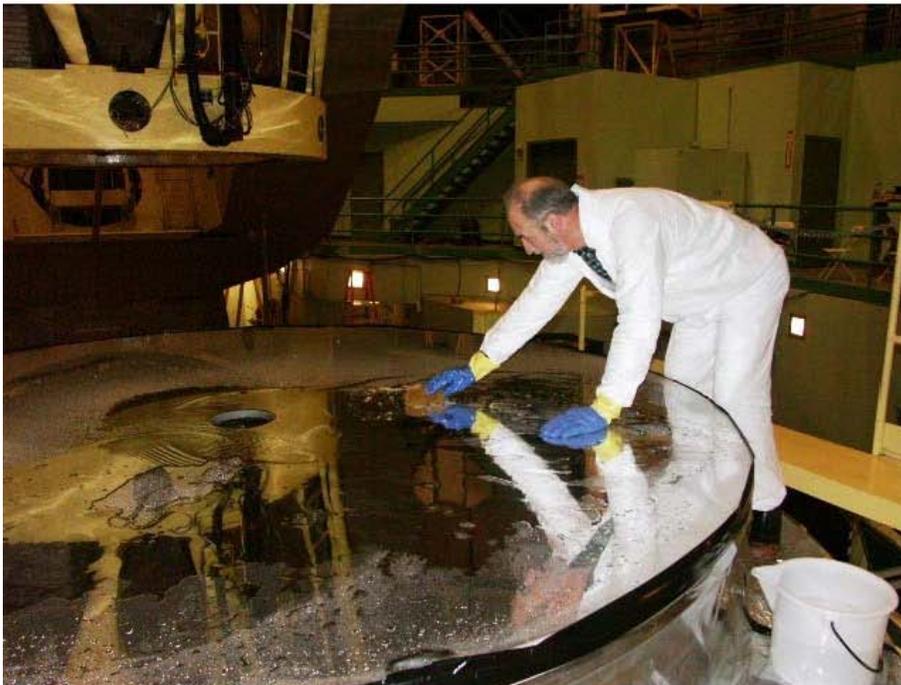
The mirror was then rinsed towards the center hole, washed with Orvus/water using natural sponges and rinsed again with tap water from the spray hose.

After washing we dried just the same four locations for the reflectometer. We repeated the measurements and found that just washing it increased the reflectivity from 73% to 83%. Since we were going to strip it we didn't worry about the water drying in spots.

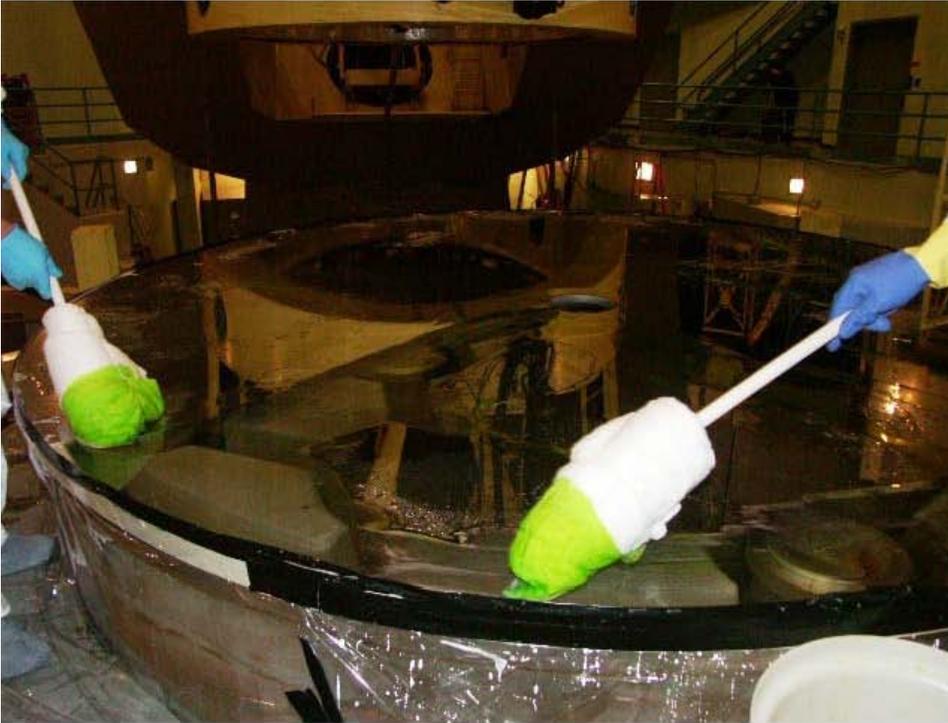
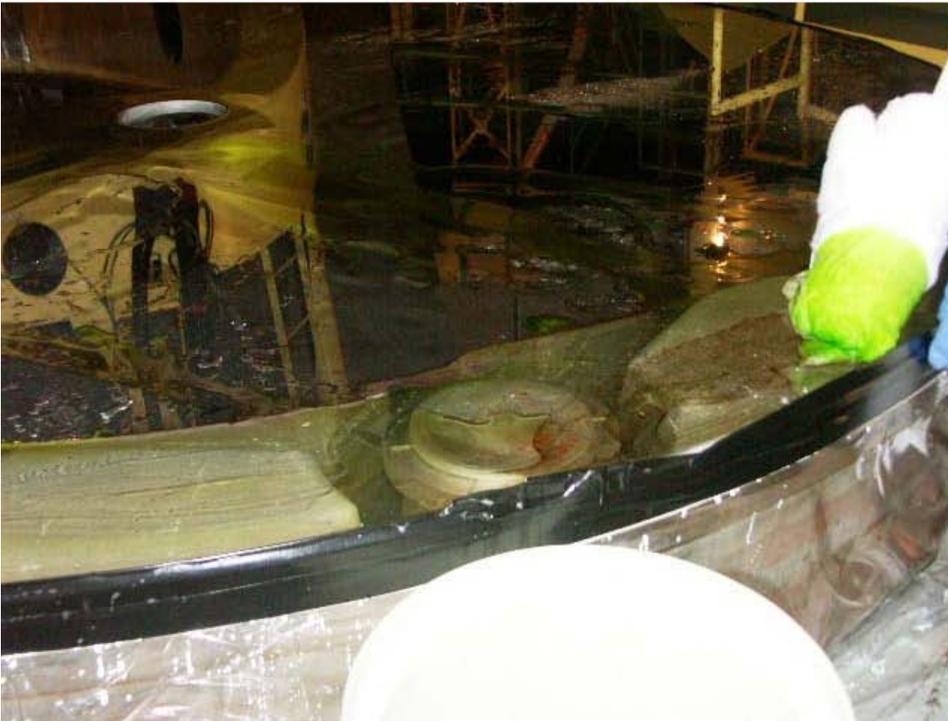
Next we stripped the aluminum off by swabbing it with the giant Q-tips dipped in Green River. It came off easily, revealing the structure of the mirror below.

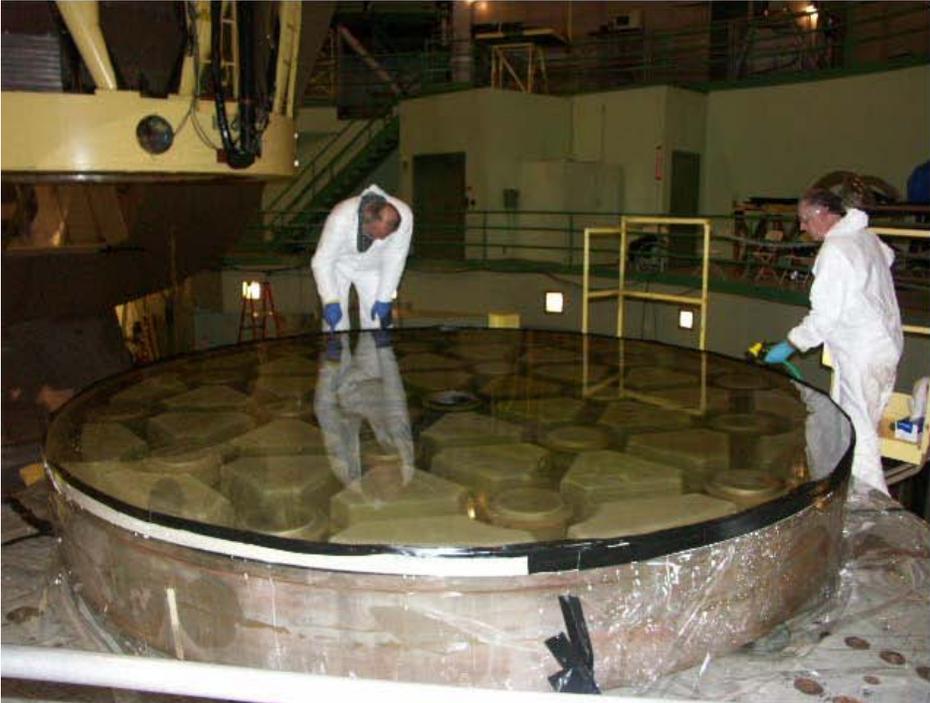
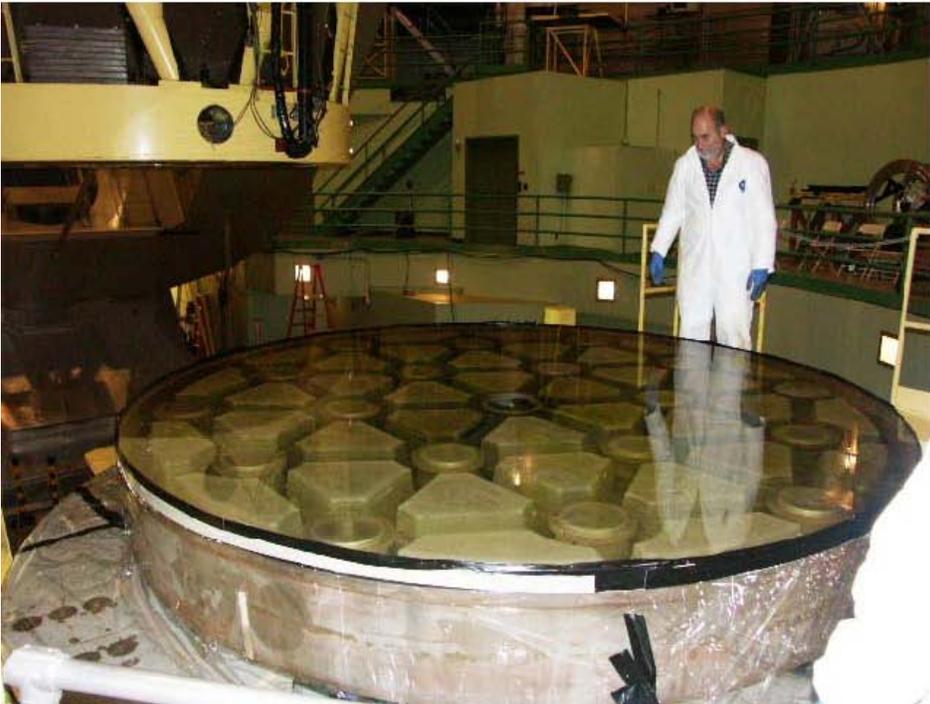
When it was all stripped we rinsed the Green River down the drain in the central hole. A second hose might have made it easier to “herd” the fluid down the drain.

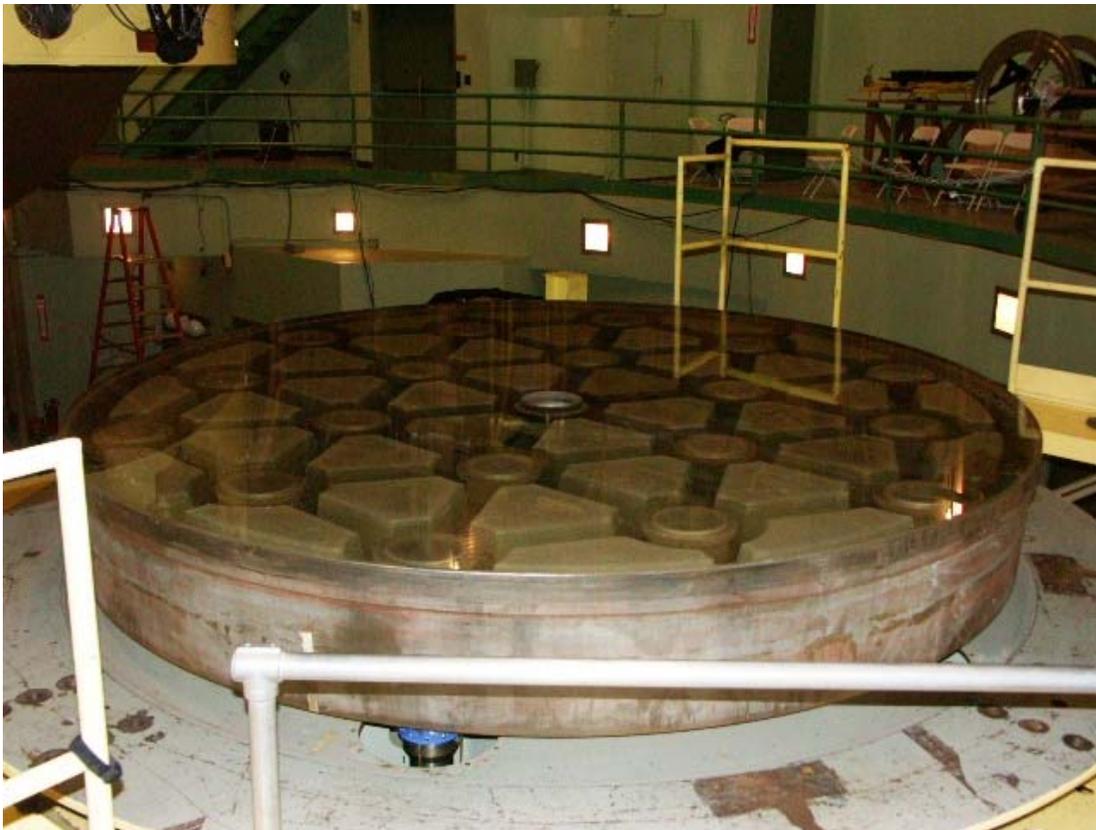
We then went right into the cleaning process by swabbing the surface with KOH / H<sub>2</sub>O using fresh Q-Tips. Bill then sprinkled copious amounts of CaCO<sub>3</sub> (calcium carbonate) on the wet surface and we used Kaydrys dipped in the KOH / H<sub>2</sub>O solution to make “toothpaste” of the CaCO<sub>3</sub>. We rubbed the surface all over and then rinsed it down the center hole. Again, a second hose might have made it easier to “herd” the fluid down the drain.

We looked for sheeting of the fluid as it washed away, and when spots were found to not be wetting we re-applied CaCO<sub>3</sub>. The perimeter never quite sheeted.

The last chemical we put on was the HCl / H<sub>2</sub>O solution, to neutralize the KOH. We let it sit for a minute and then washed it away. A step that we inadvertently left off was rinsing again with copious amounts of de-ionized water, which we had available but forgot to use.

We dried the water off with Kaydrys, being careful not to let the spots air-dry. We also were careful not to touch the surface with our gloved hands. To reach the middle we used a wad of Kaydrys under the hand that supported our weight while we dried with Kaydrys in our other hand.

Finally, we carefully removed the vinyl barrier and mopped up any fluids that leaked through to the platform.

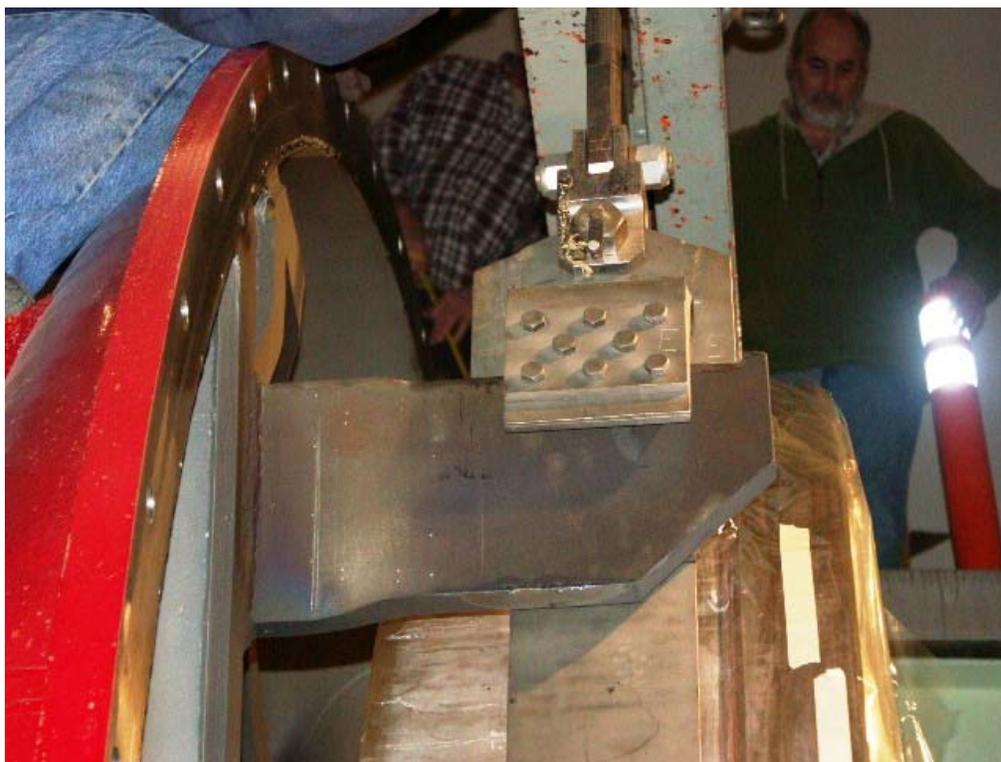
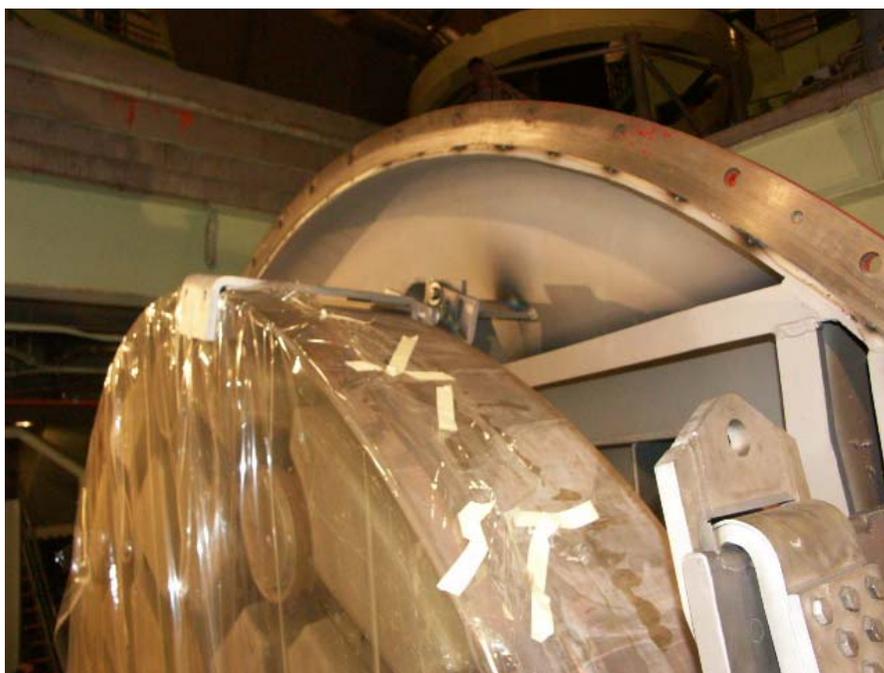
The mirror was anchored from moving inside the tank by a custom connection between the "earthquake clamp" on the mirror at the top.

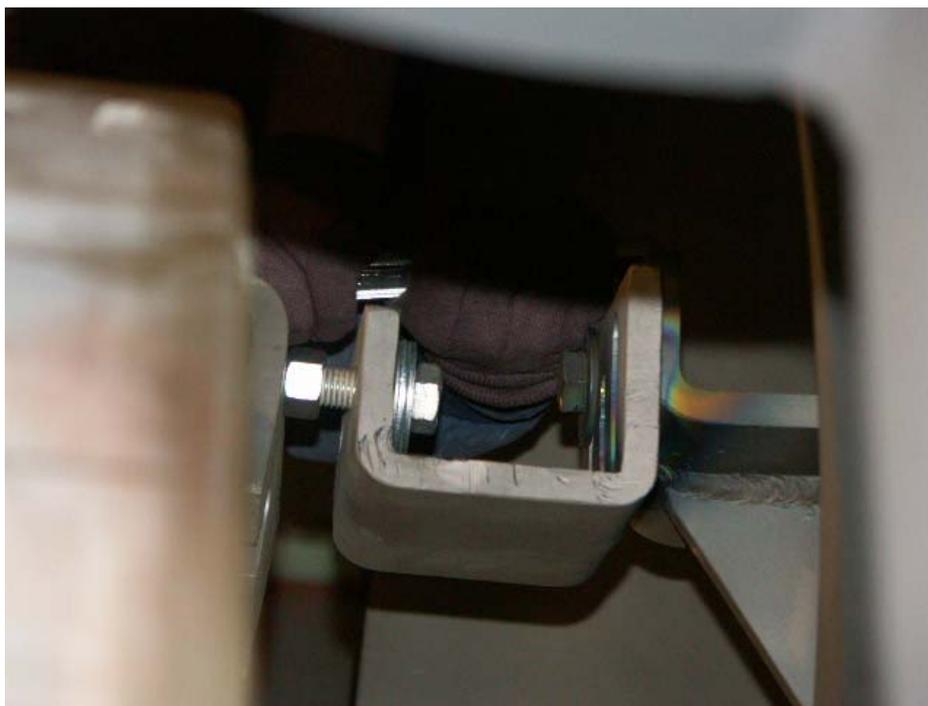
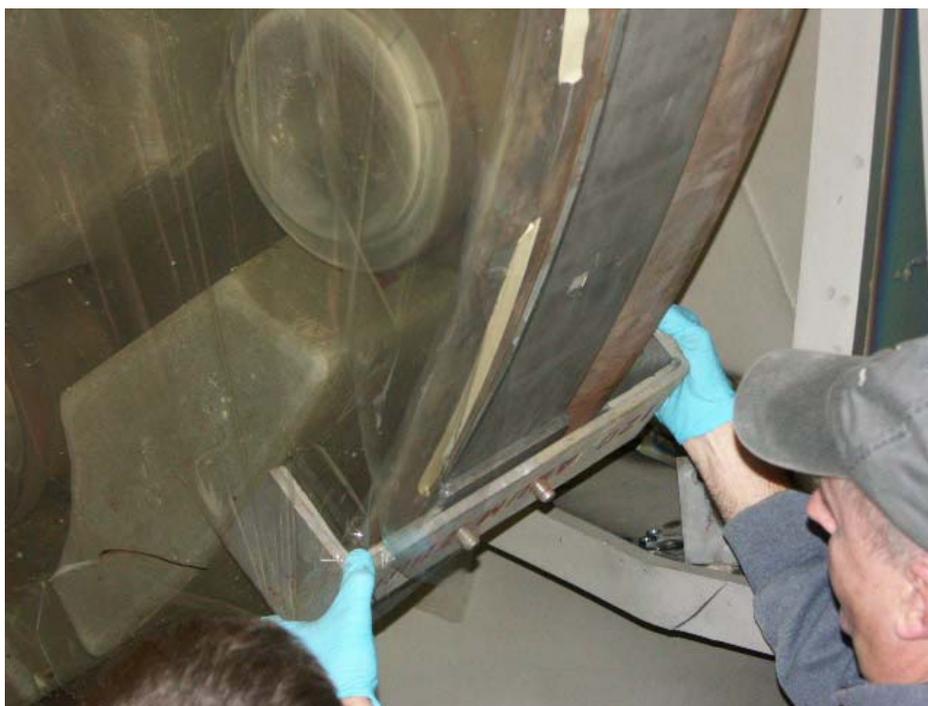
Another anchor was made by removing an “earthquake clamp” from one side and using the bolt on the belly-band to secure it to a fixed bracket in the tank.

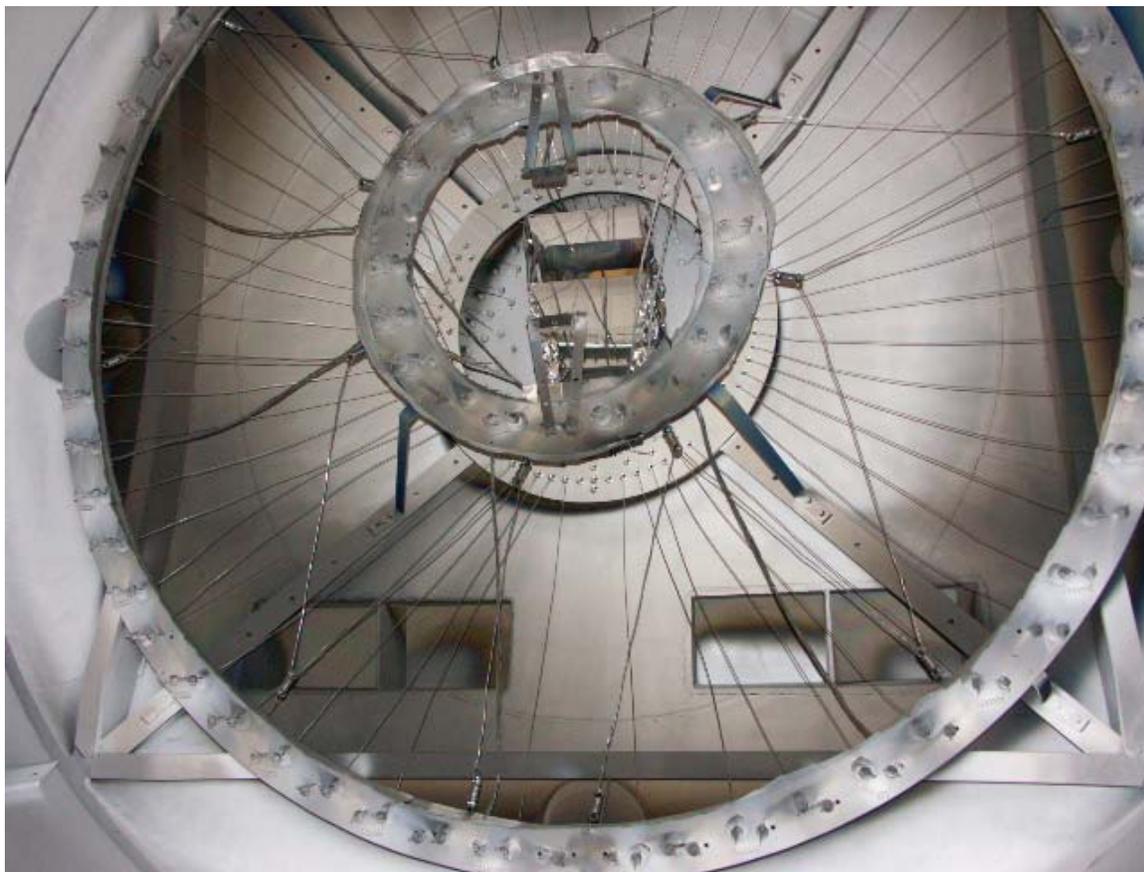
Here is a picture of the filaments of the tank...they are hard to see in the picture but basically go between the pairs of screws around the two rings. They look like thick light bulb filaments and have staples of aluminum (10 or 12, roughly) hung from each one. Note that there is an inner ring of them and an outer ring. They are addressed separately during coating. The first few filaments (verify) of the inner ring are "getters" designed to lower the pressure in the tank. The aluminum that comes off them is directed away from the mirror. The two vertical brackets are to hold SiO<sub>2</sub> boats, I believe (verify).

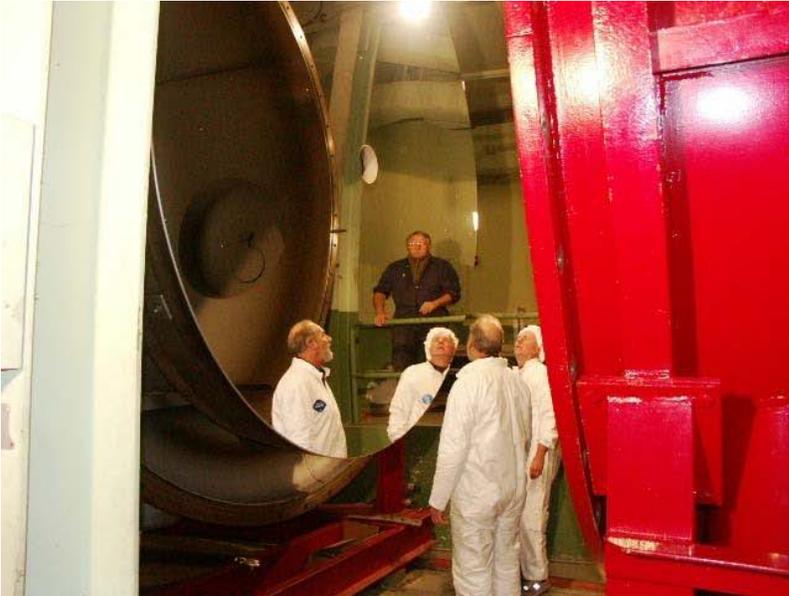
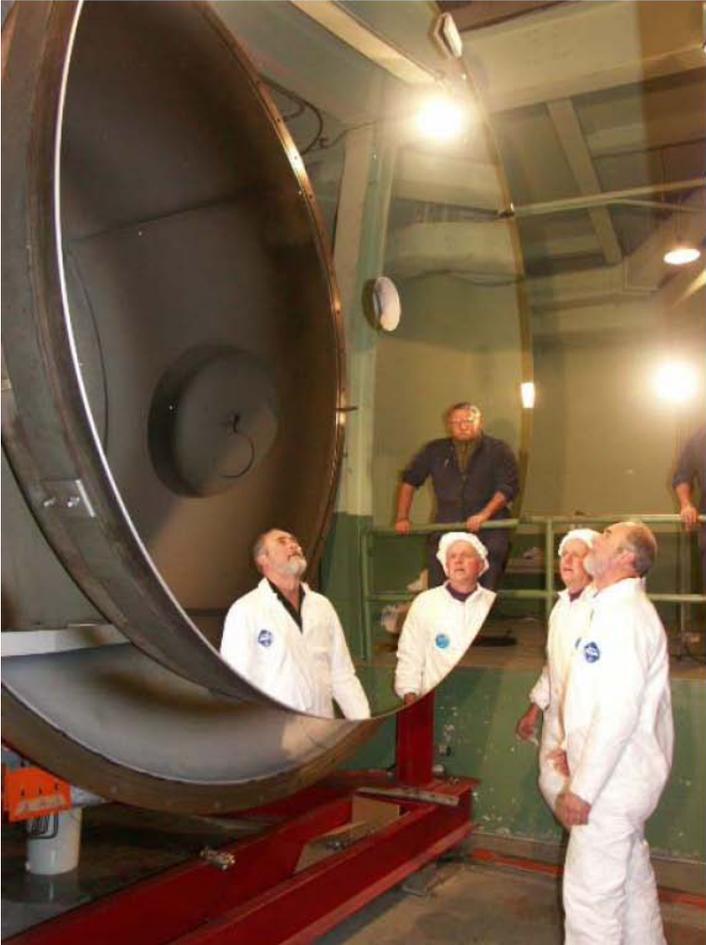
On the third day we did a more thorough inspection of the surface.

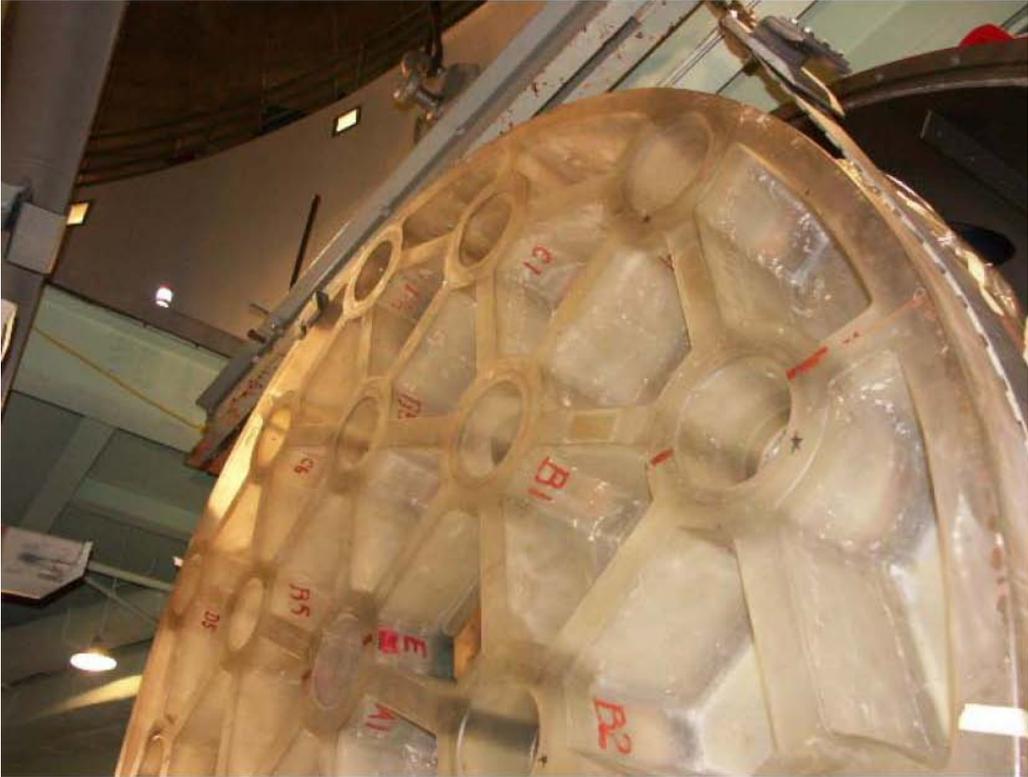
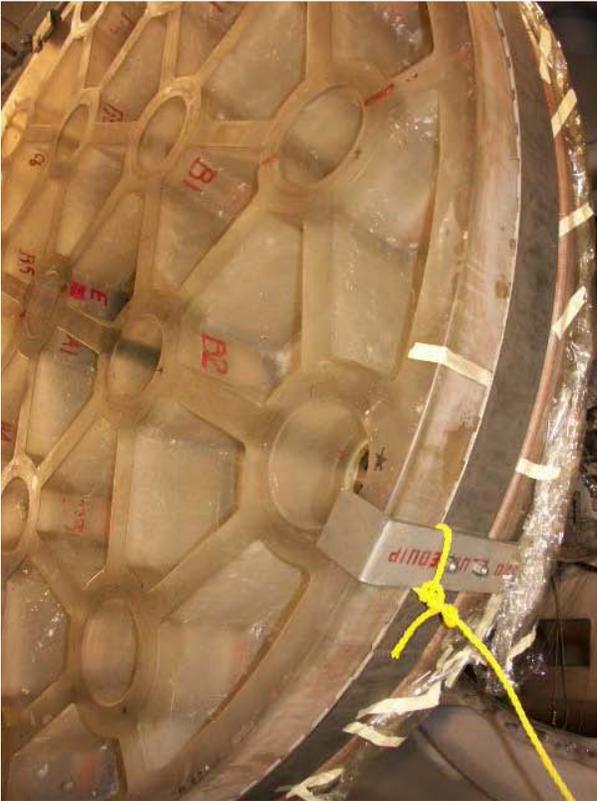
The mechanical team replaced small (approx 5/8") O-rings and adjusted set screws in the rings in the back of the mirror.

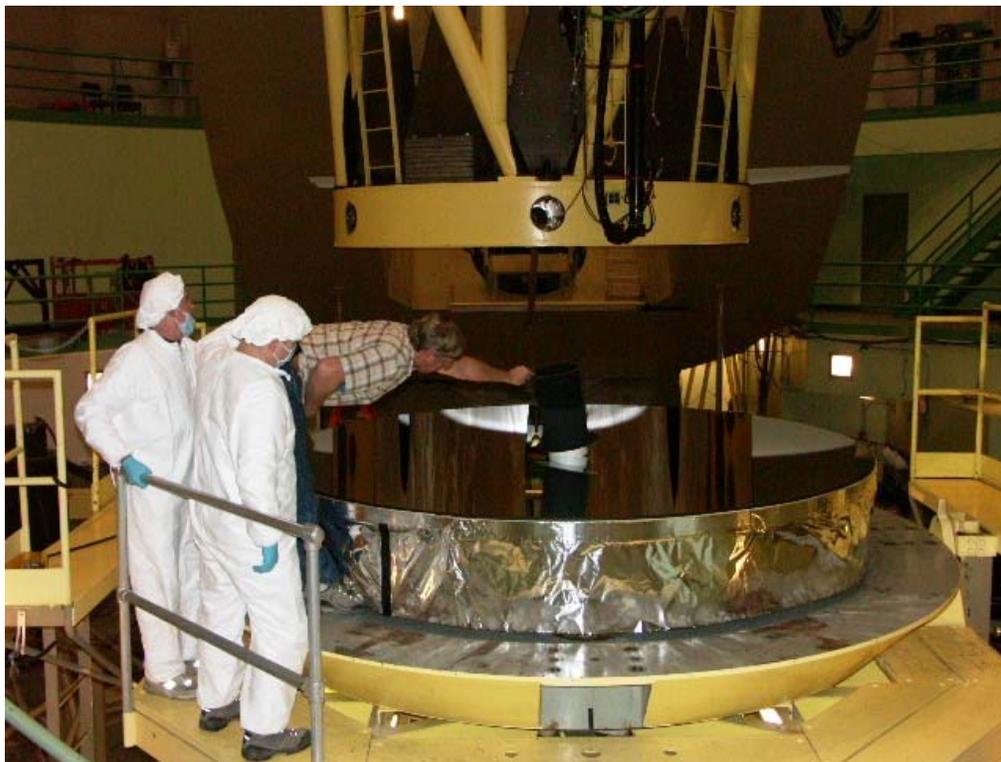
Darrell put the “top hat” back into the center hole of the mirror...he was supported by two people hanging on to his belt.

We left the mirror out in the open since there are known to be drips of grease that at times come off the telescope...however, it was moved under the telescope later that night anyway.

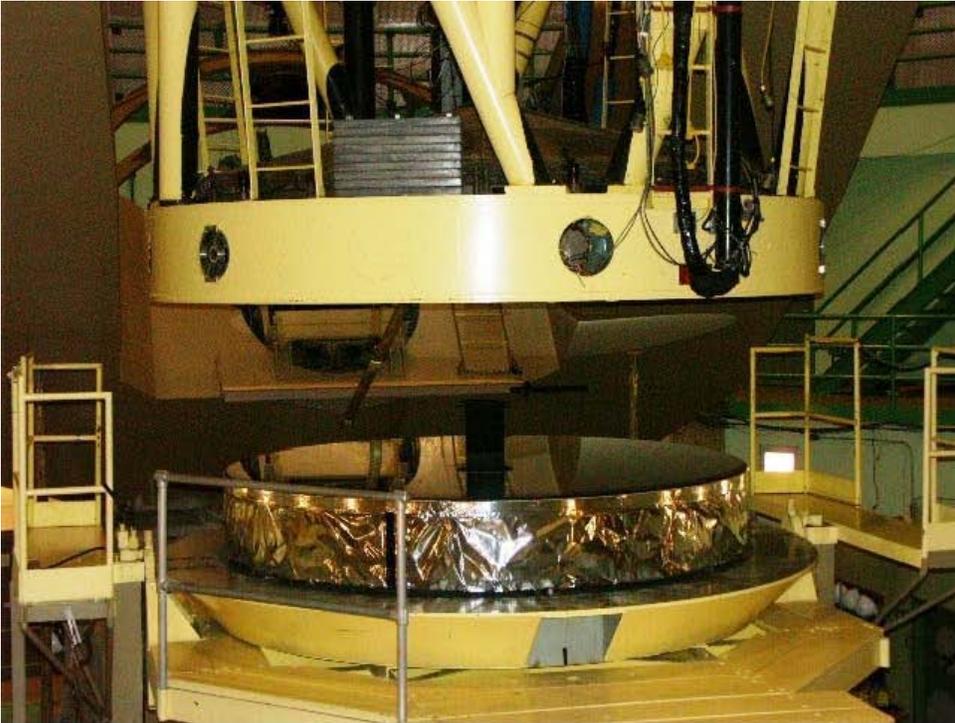
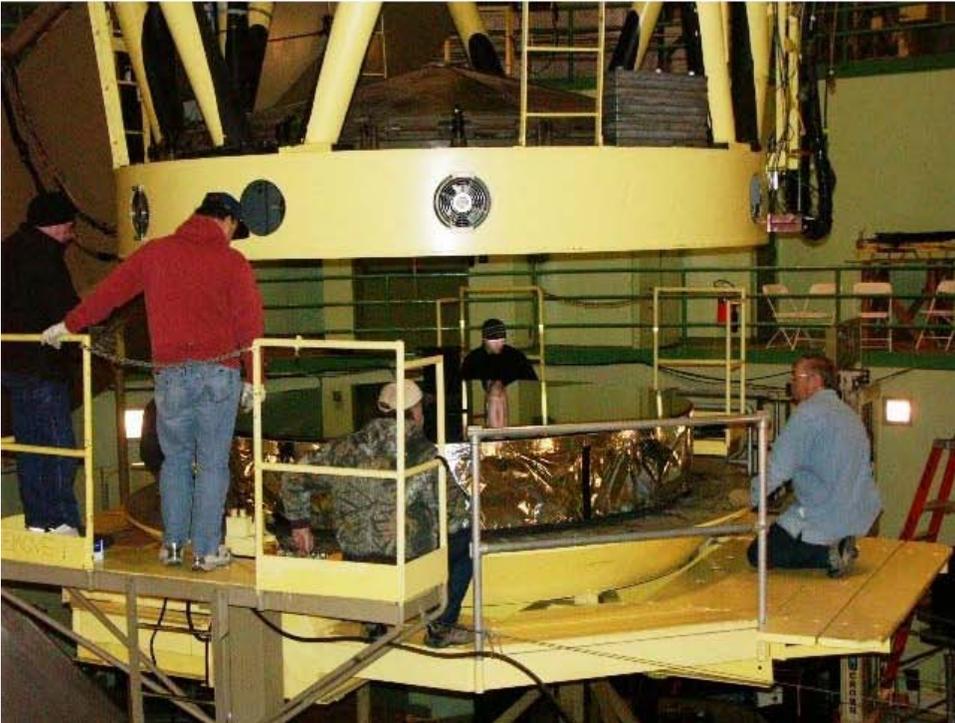
On the last day of the process the mirror was bolted back onto the telescope.

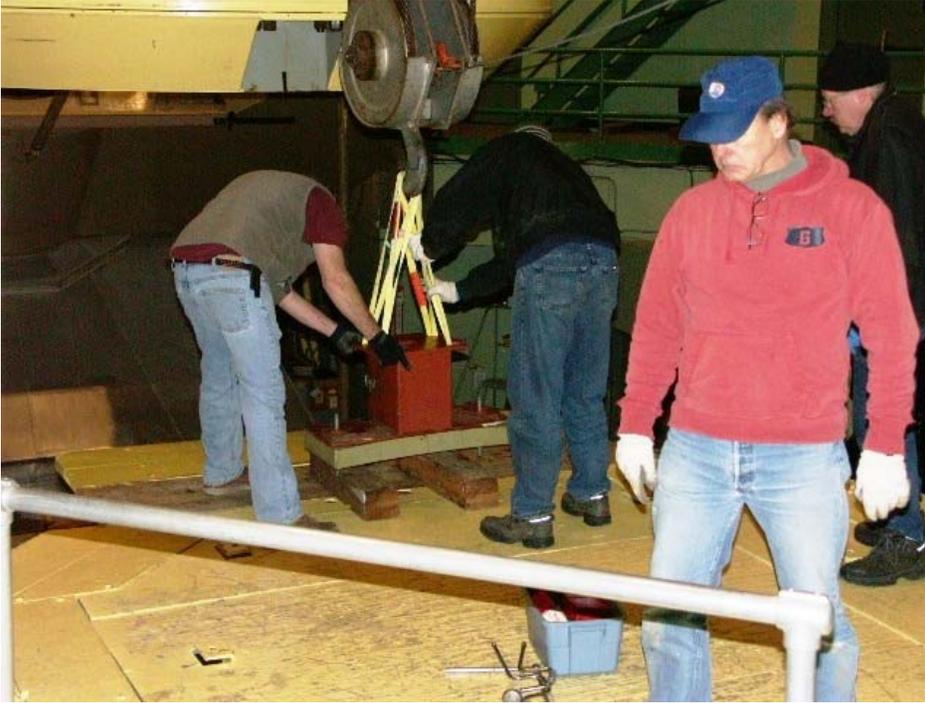
Four heavy weights were bolted to the mirror. For some reason, the southernmost one was put on first, separately from the others.

Later the other three were put on the platform. It was noted that the alignment marks for the weights had been painted over, so there was some pushing and pulling on the massive weights that was required to get them in to position. Next time the mirror comes out the positions of the weights should be re-marked before they are taken off. This will make replacing them much easier.

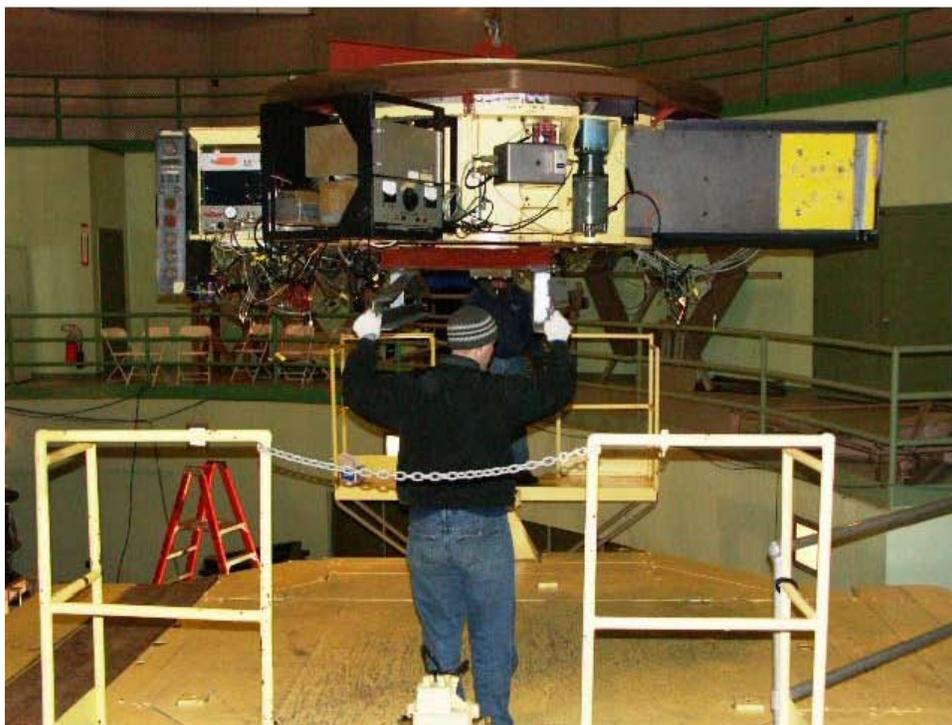
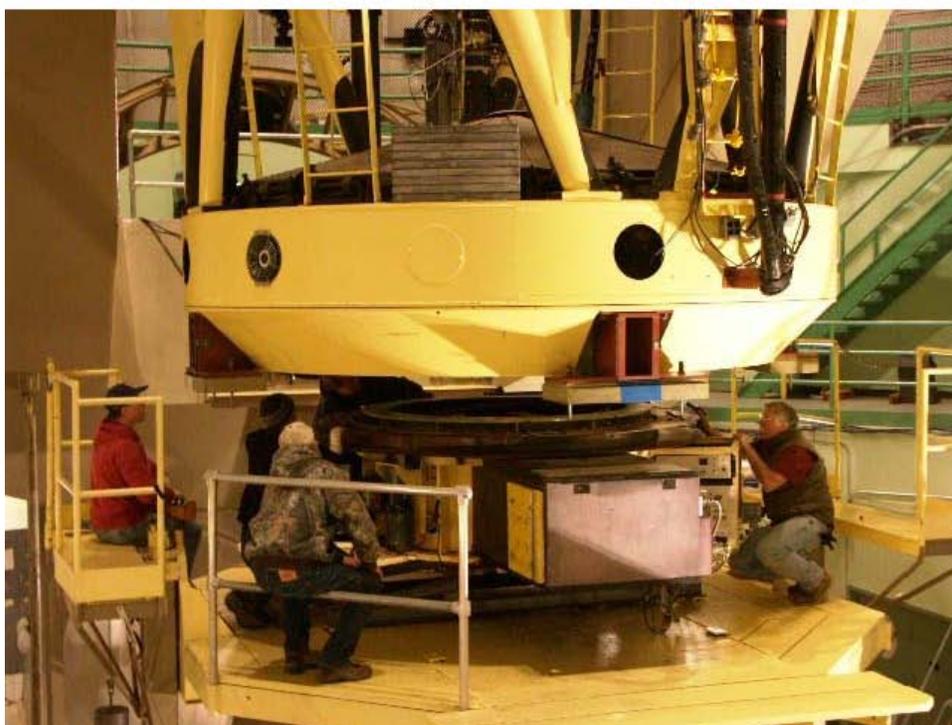
Then the “hub” of instruments was hoisted over to the platform and re-attached to the telescope.

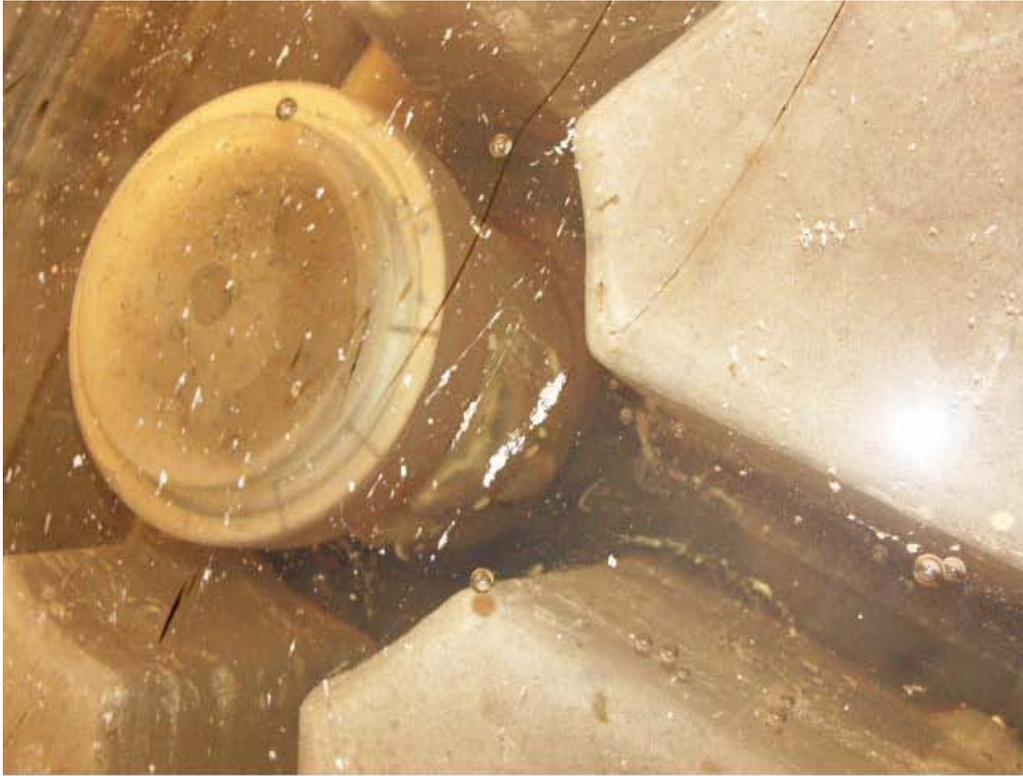
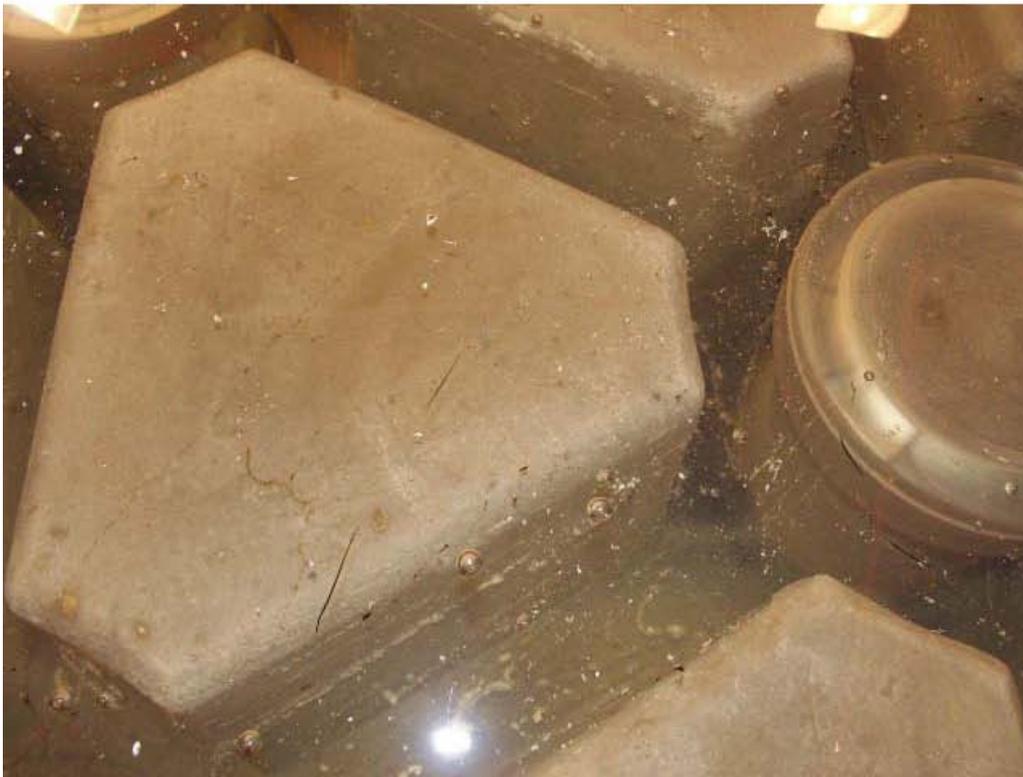
There were lots of floating debris and swirls of brown fluid beneath the surface.
