# 120 INCH TELESCOPE PRIMARY RECOATING

February 13 – 16, 2006

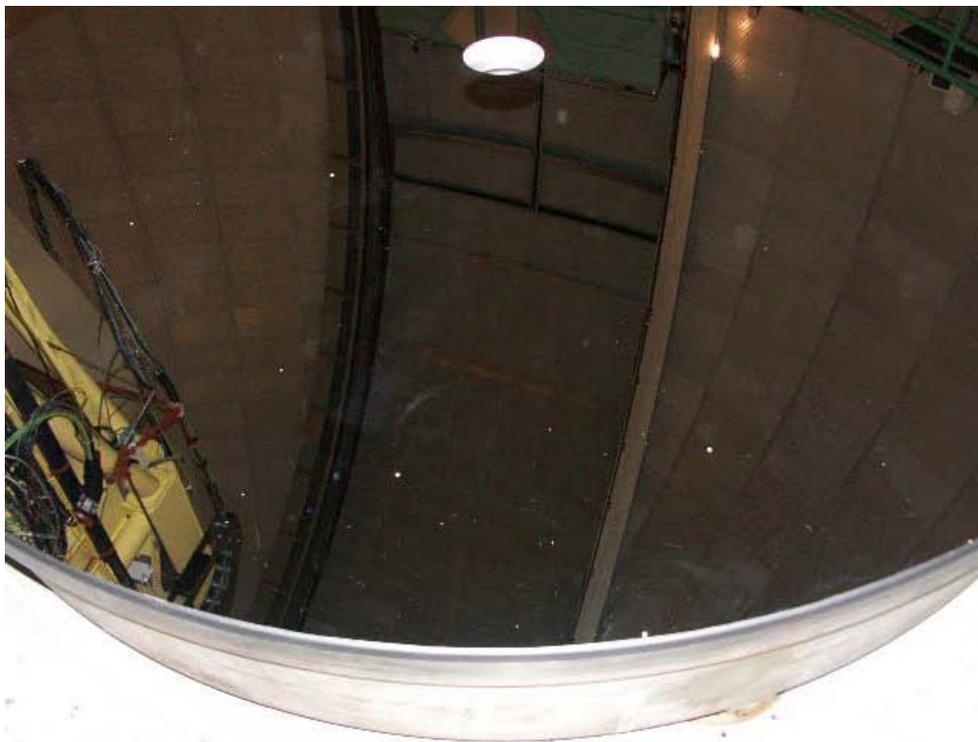
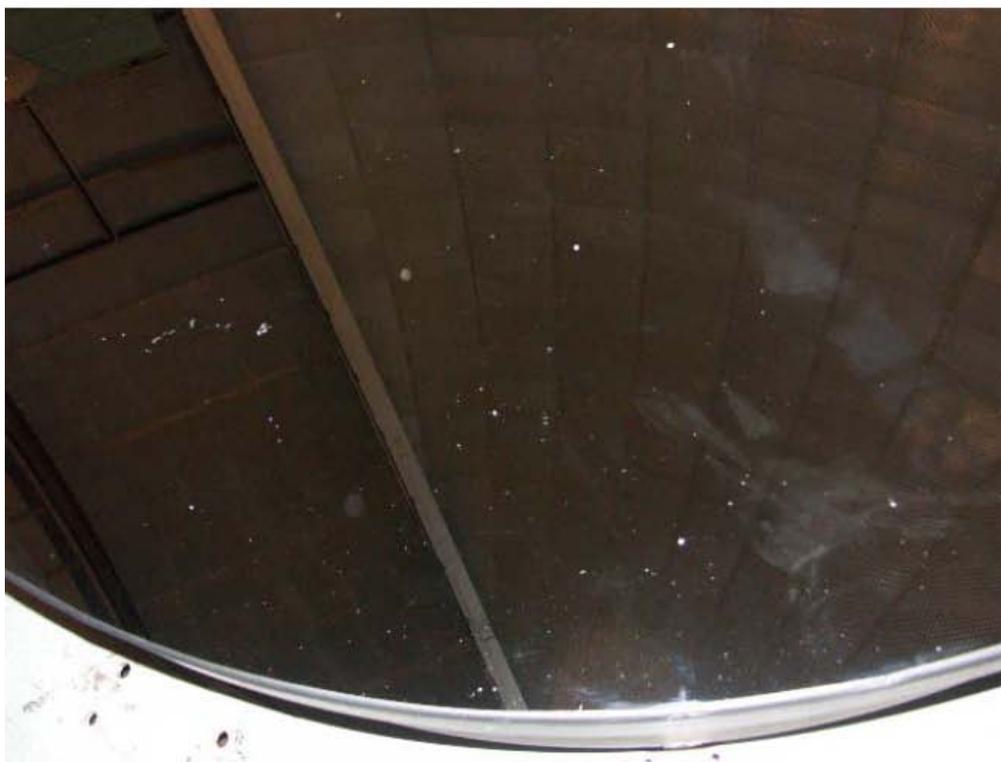
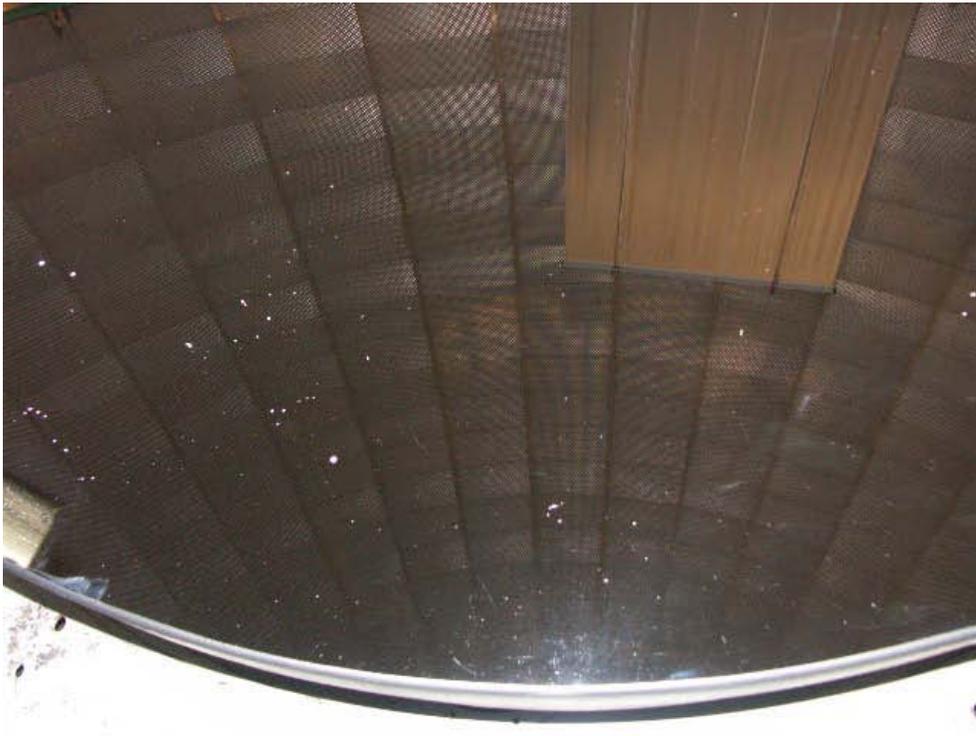
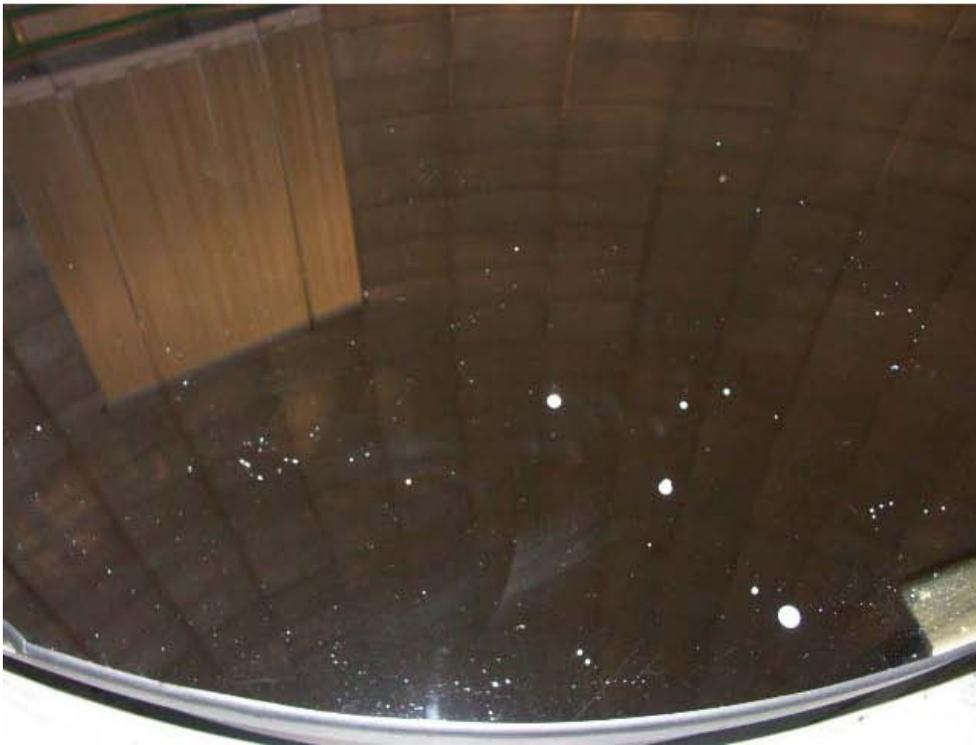
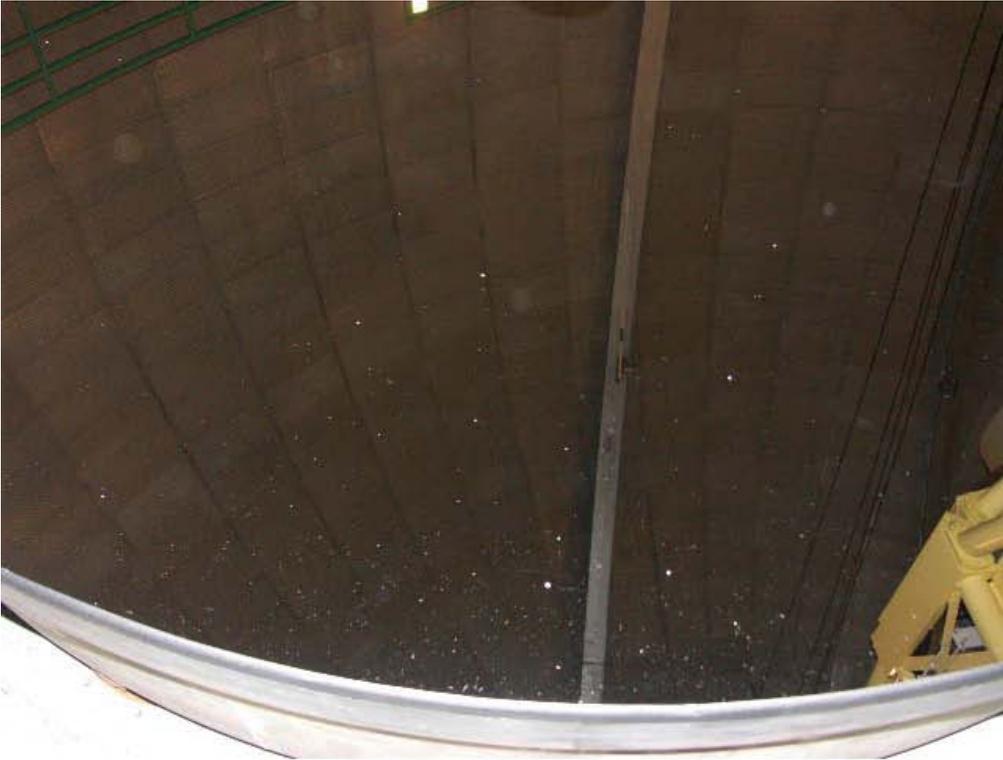
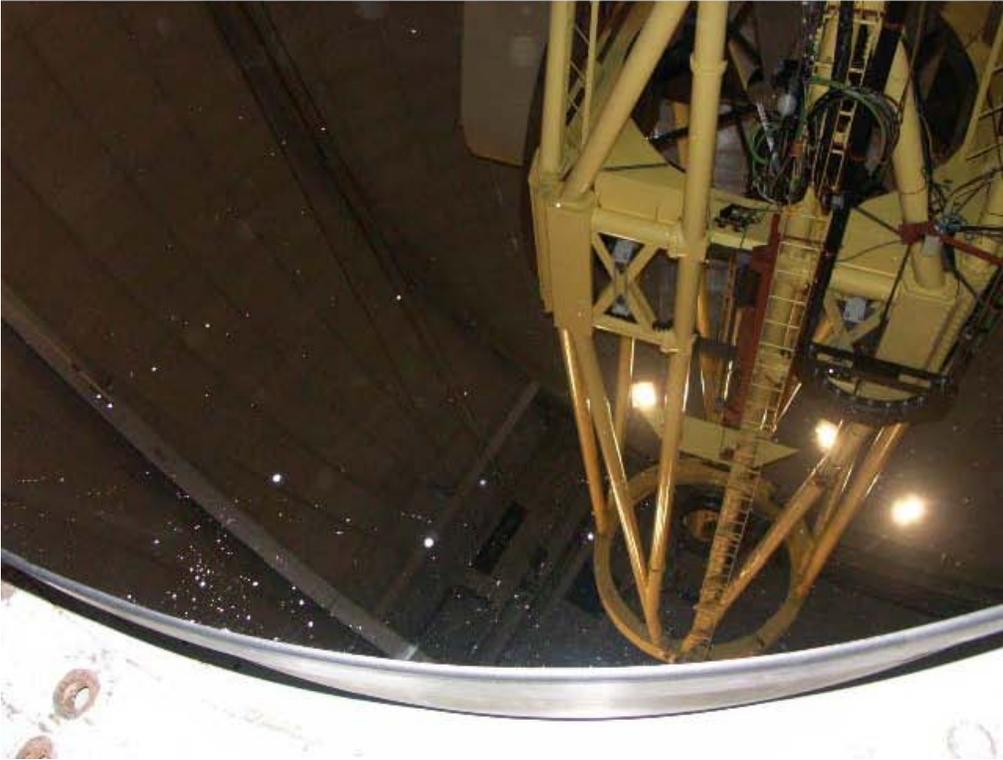
## Addendum 3 – New mirror surface

These six pictures were taken starting from standing at the NE position as the mirror sat on the platform and moving around it clockwise.
